This document is an English translation of the Final Report on the accident on 10 April 2010, on Smolensk "Severny" airdrome, to the Tupolev Tu-154M tail number 101 of the Republic of Poland.

**INTERSTATE AVIATION COMMITTEE
AIR ACCIDENT INVESTIGATION COMMISSION**

FINAL REPORT

| Type of aircraft | Airplane, Tu-154M |

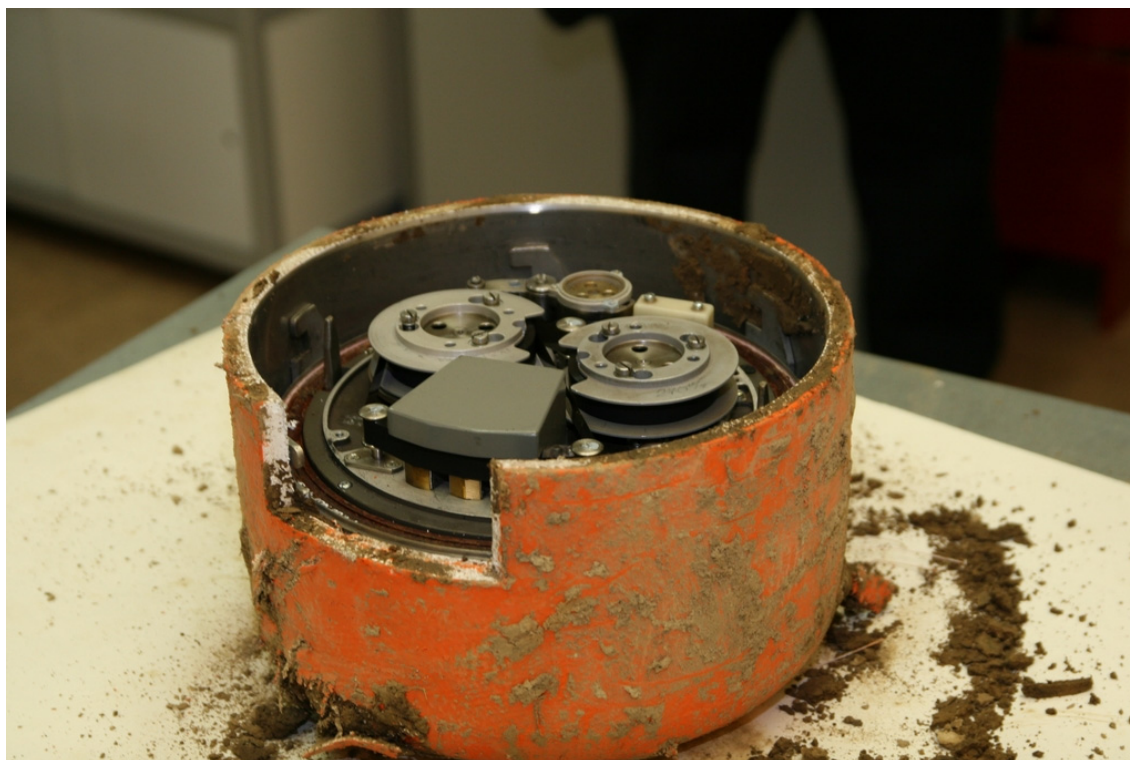
Figure 18

The opening revealed that the tape was in good condition, loaded in the recording track, springs armed (Figure 18).

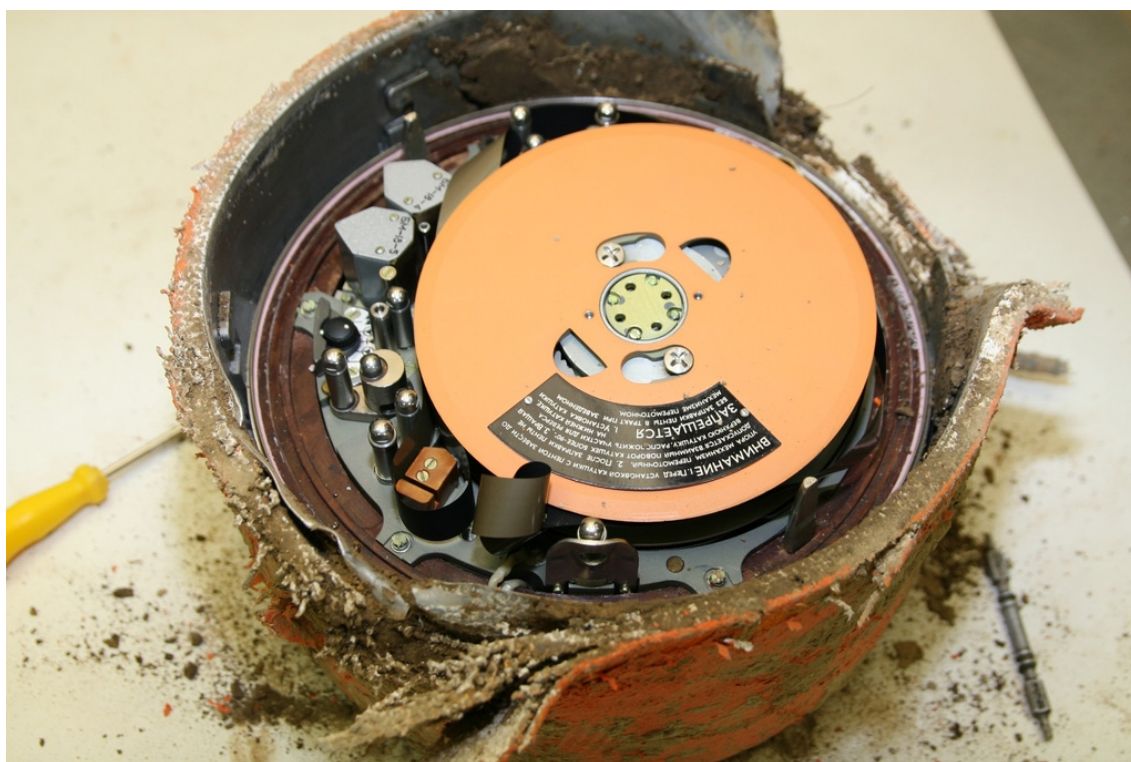
Figure 19

The casing of the protected MLP-14-5 № 90969 was significantly damaged mechanically, the mounting frame and casing lid were missing, the linkages were torn. The catch gear was filled with earth (Figure 17). The visual examination of the FDR after the opening revealed that the tape was on spools, but out of the recording track. The tape was in good condition, the mode switch in Automatic position (Figure 19).

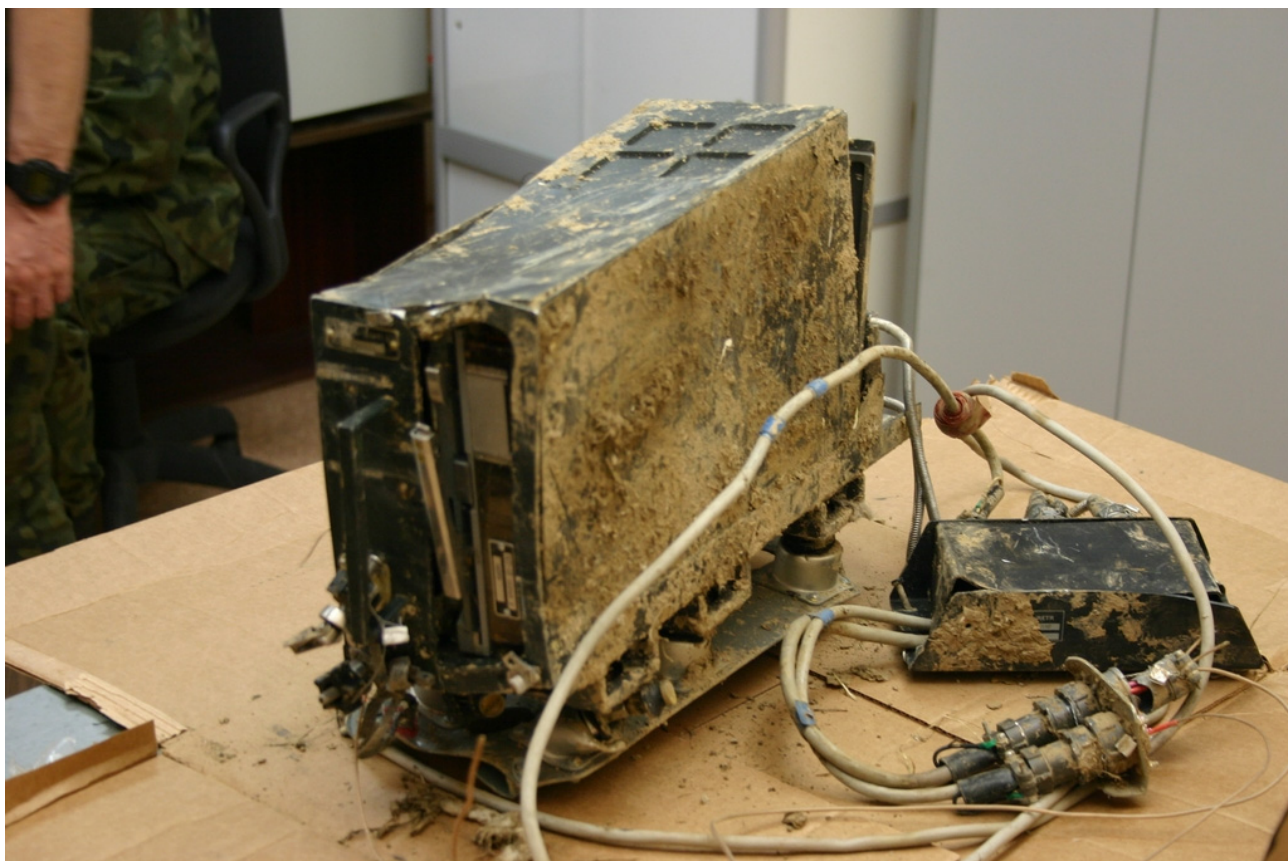
Figure 20

This QAR is non-protected and records the same list of parameters as the FDR for the last 17...30 hours. The QAR casing was found deformed (Figure 20), the KS-13 series 2 № 461195 tape memory unit was extracted from its normal place after the QAR geometry was recovered.

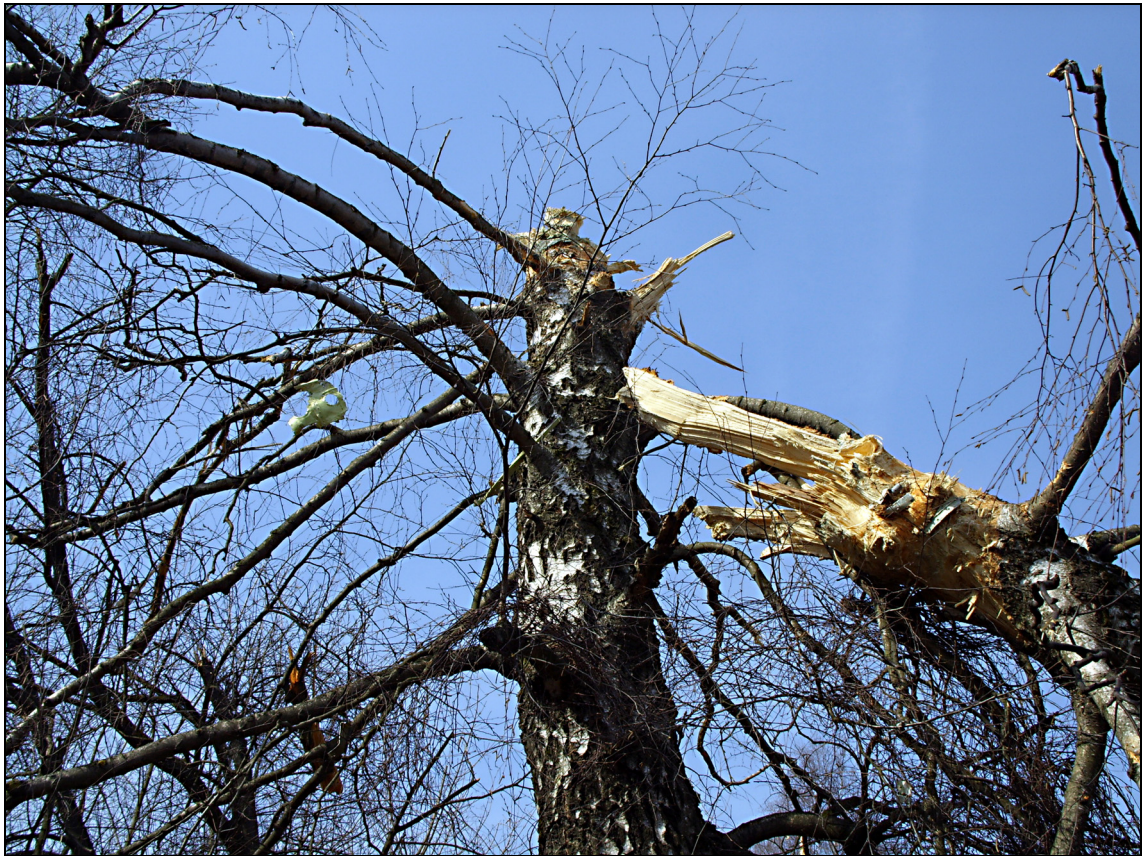
Figure 27

At a distance of 244 m from the first impact with lateral deviation of 61 m left from the extended runway centerline at a height of about 5 meters the aircraft hit a birch with a trunk measuring 30-40 cm in the diameter (Figure 27 and Figure 35).

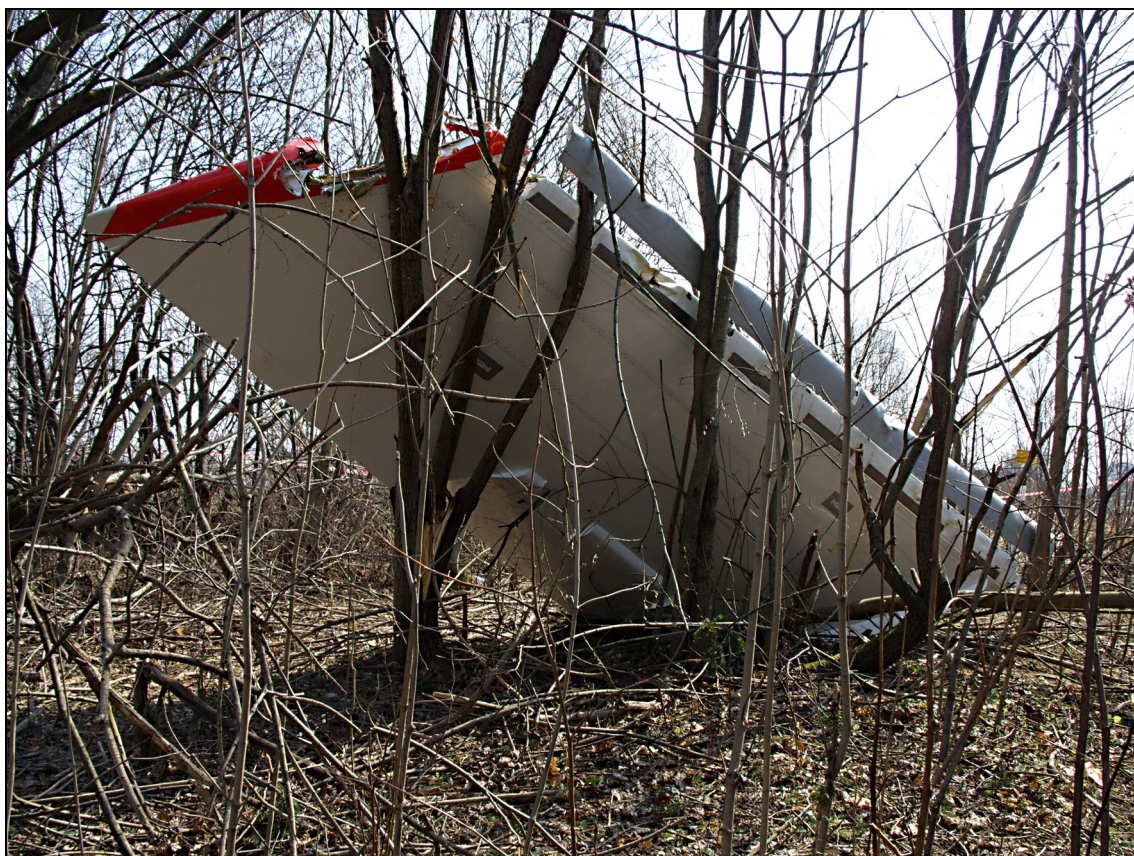
Figure 28

In the area of the impact the investigation team found fragments of the left detachable part of the wing including: fragments of left detachable part of the wing panel jammed in the tree trunk, a fragment of the left aileron spoiler, the fairing of the flap jack screw, fragments of the left slat, fairing of the left outer flap, the left flap track, a flap housing. All the fragments found along the aircraft flight path for the following 150-200 m were elements of the left detachable part of the wing (Figure 28).

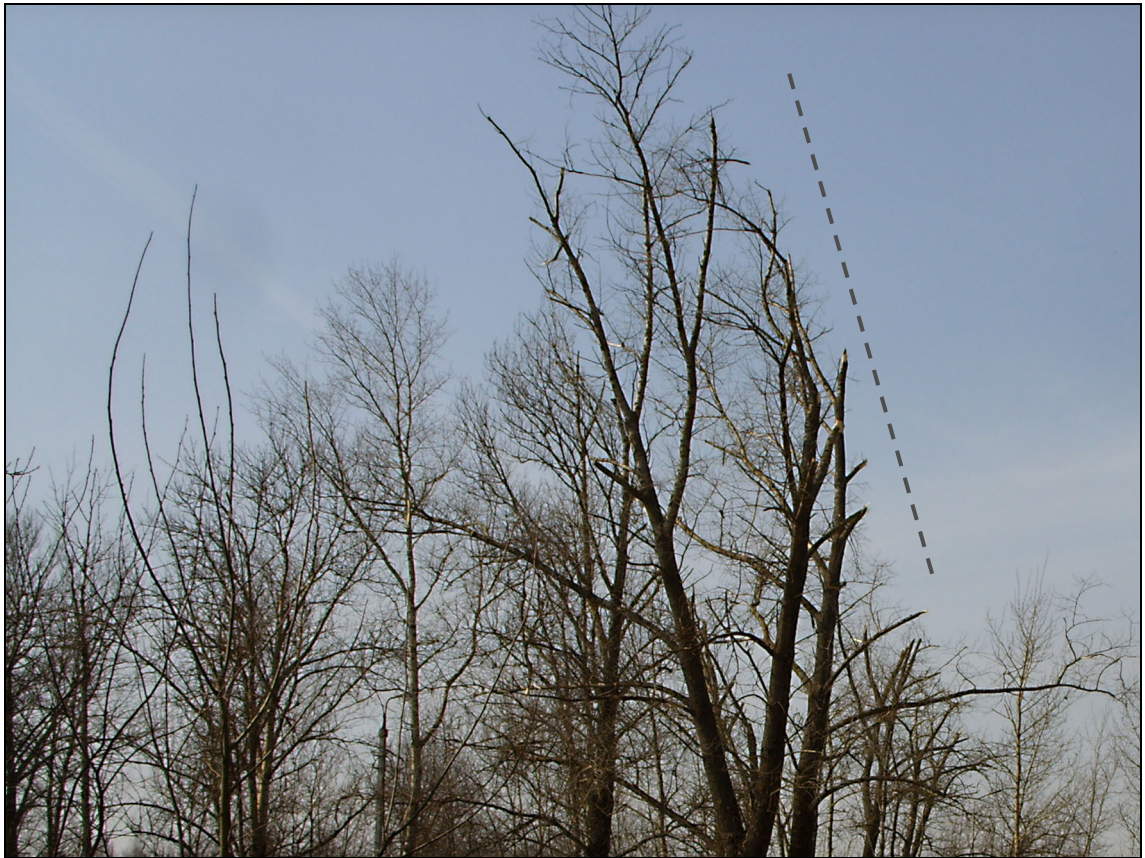
Figure 29

While rotating and moving farther the aircraft got further structural damages caused by the impact on the trees. The nature of the tree rip-off at a distance of 465 m from the first impact assumes that by that moment the left bank was over 90° (Figure 29 and Figure 36); at a distance of 530-550 m from the first impact the investigation team found fragments of the wing primary structures partition, fragments of the left stabilizer panel with elevator and rudder and elevator rods.

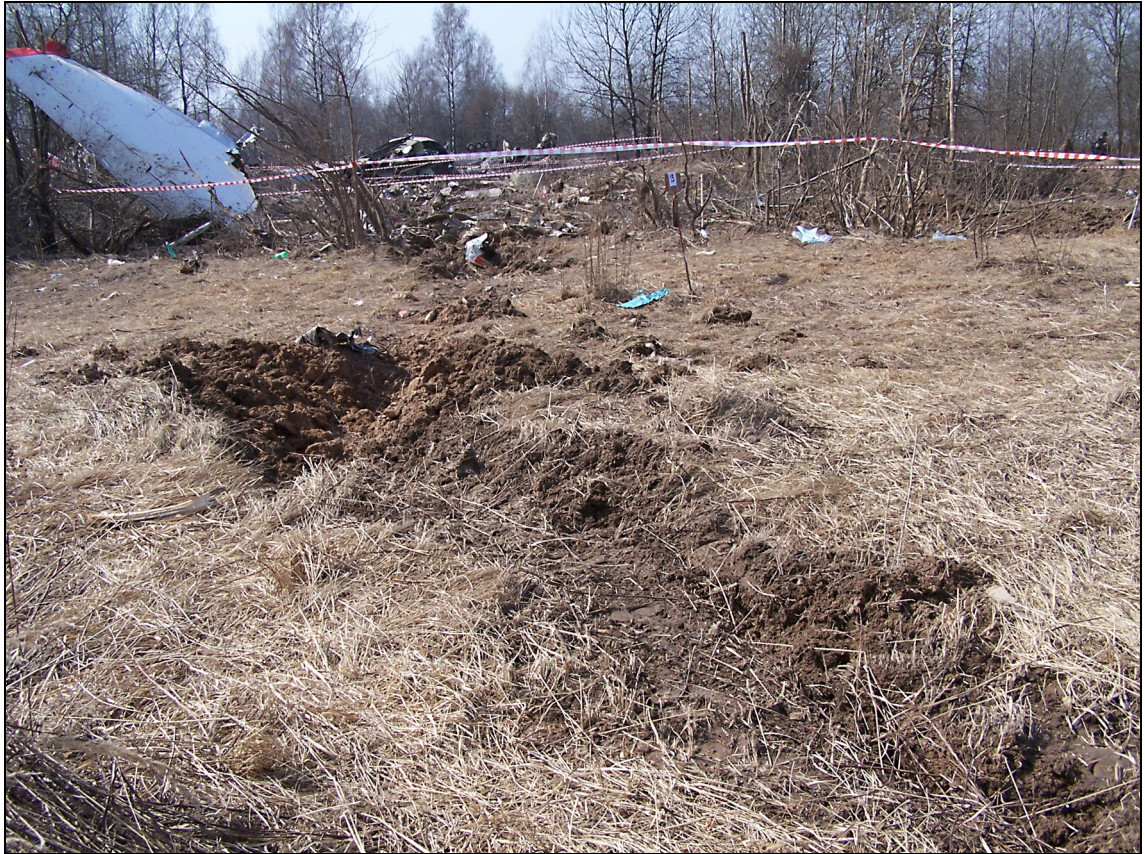
Figure 30

The first ground impact was at a distance of about 580 m from the first impact (Figure 30).

The site of ground impact has a furrow made by the stabilizer and fin leading edges up to 0.5m deep and 22 m long with fragments of the SI-2U light of the SMI-2KM lighting set as well as a furrow made by the left wing up to 0.4 m deep and 22 m long with fragments of the left wing panel and rod №154.83.5711-090-009.

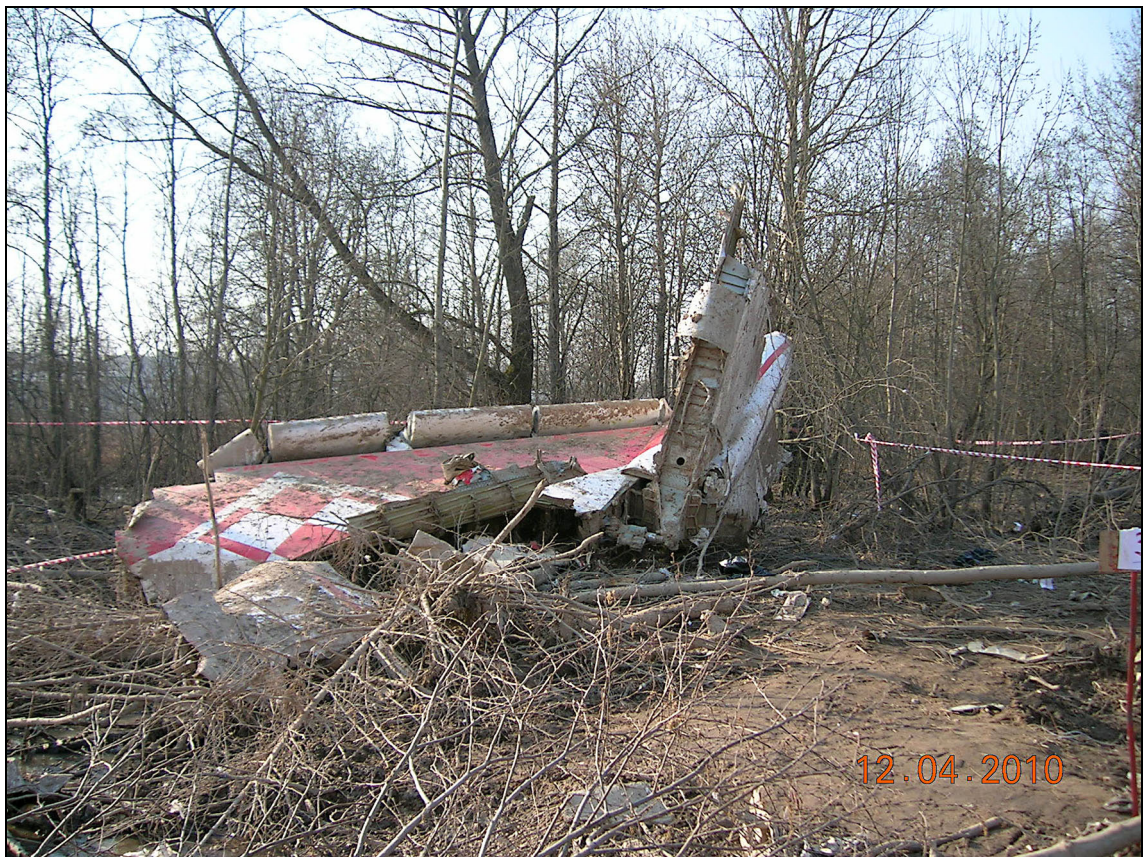
Figure 31

On impact the right stabilizer panel with elevator, the fin with rudder (Figure 31), tail cone and stabilizer roots were ripped off and found 590-620 m from the point of the first impact.

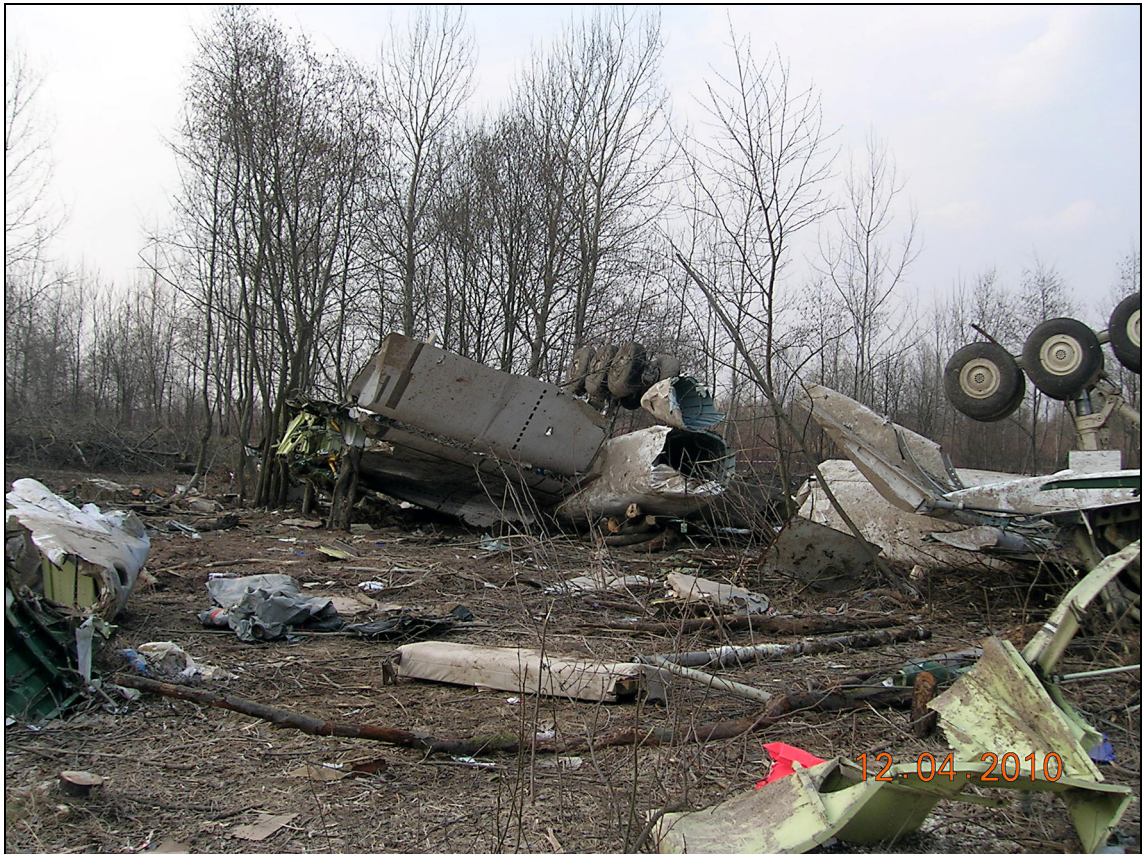
Figure 32

The wreckage area along the aircraft path is about 130 m long and 30-50 m wide, with lateral deviation from the extended runway centerline of 100 to 160 m. Within the whole wreckage area there are multiple fragments of airframe and aircraft systems (Figure 32). The center of this area is located N 54°49.450' and E 32°03.041' at a distance of 670-680 m from the place of first impact (about 420 m from the runway threshold).

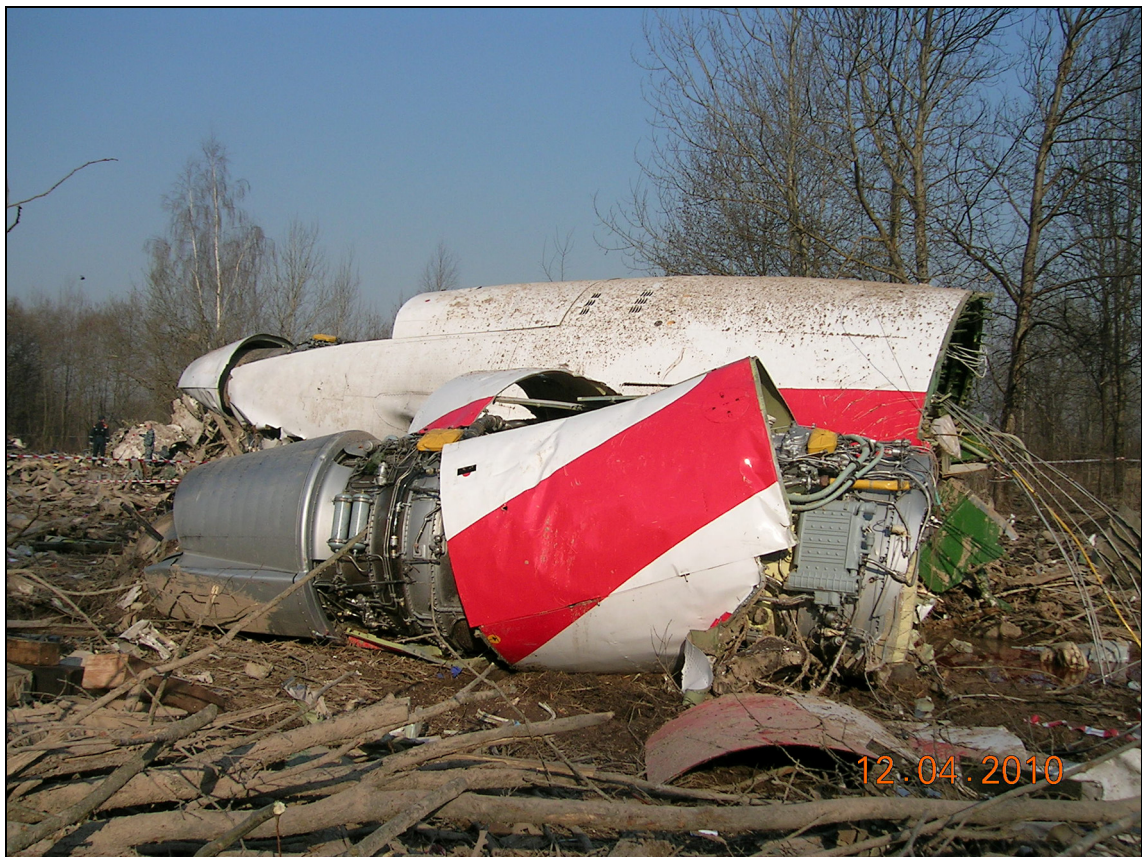
Figure 33

The tail part of the aircraft with Engine №2, pylons of Engines №1 and №3 and other engine fragments is located along the aircraft path (aircraft was moving upside down) at a distance of 436 m from the runway threshold and turned 180° against the movement direction. Engine №3 was torn off the mounts in the tail part of the fuselage and lies at a distance of 467 m from the runway threshold inverted (Figure 33). Engine № 1 was torn off its mounts and lies inverted near the tail part of the fuselage.

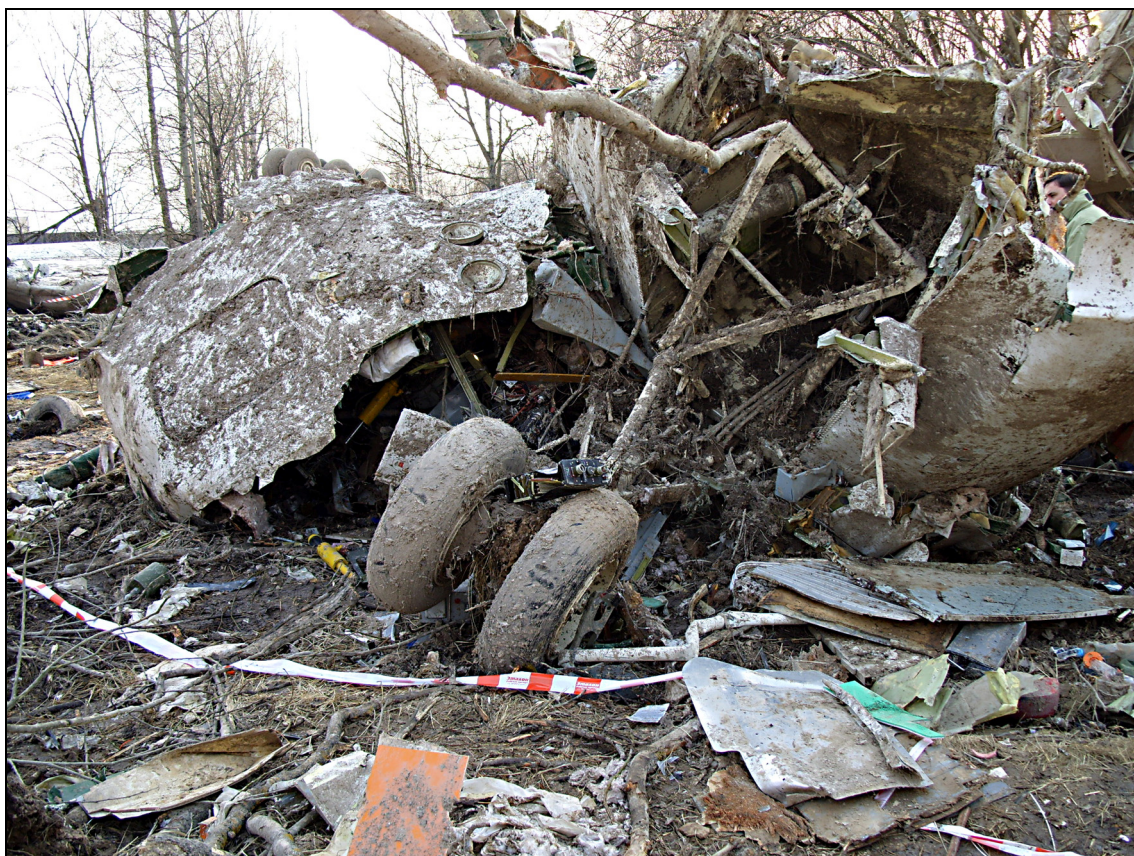
Figure 34

The forward fuselage with the cockpit was totally destroyed. A fragment of the nose with nose gear strut was at 397 m from the runway threshold (Figure 34). The upper and side skin panels were destroyed. The nose landing gear was in extended position.
