This document is an English translation of the Final Report on the accident on 10 April 2010, on Smolensk "Severny" airdrome, to the Tupolev Tu-154M tail number 101 of the Republic of Poland.

**INTERSTATE AVIATION COMMITTEE
AIR ACCIDENT INVESTIGATION COMMISSION**

FINAL REPORT

| Type of aircraft | Airplane, Tu-154M |

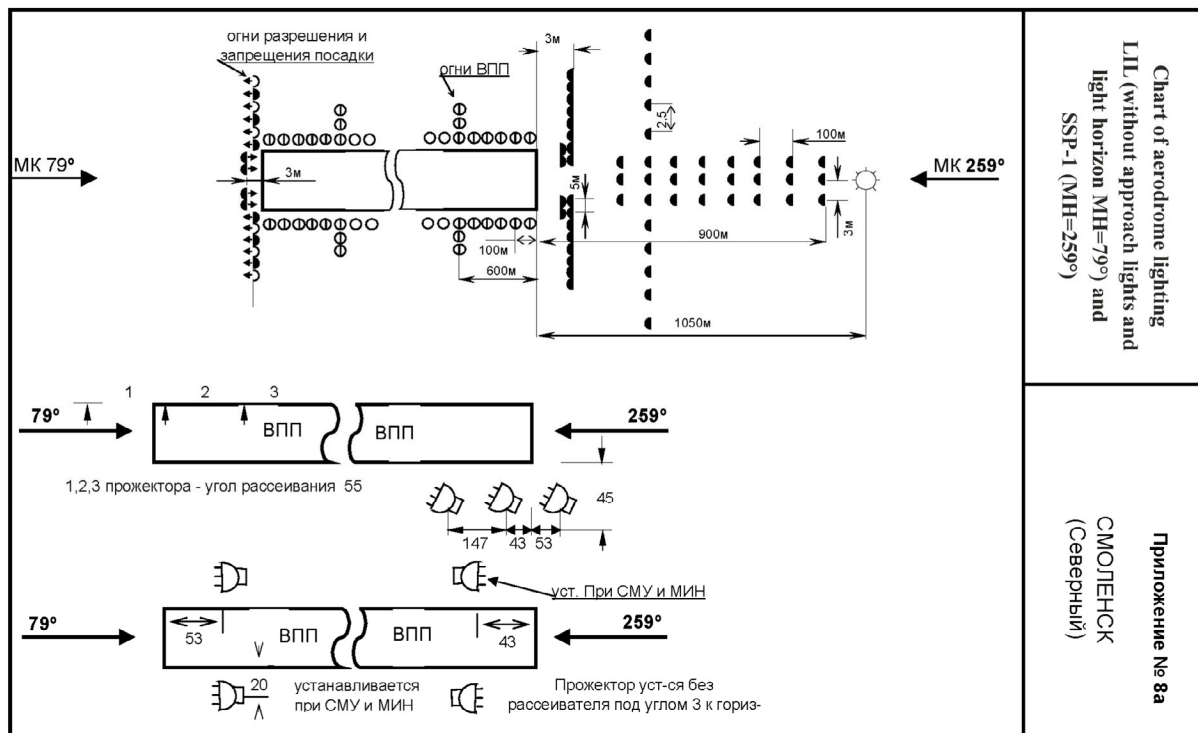
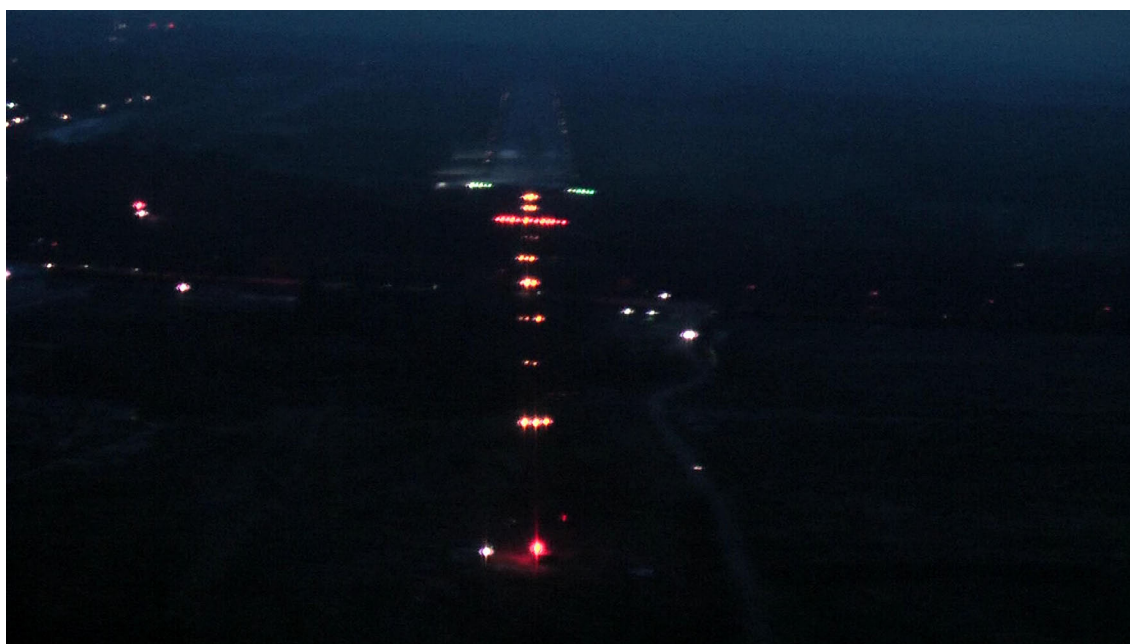
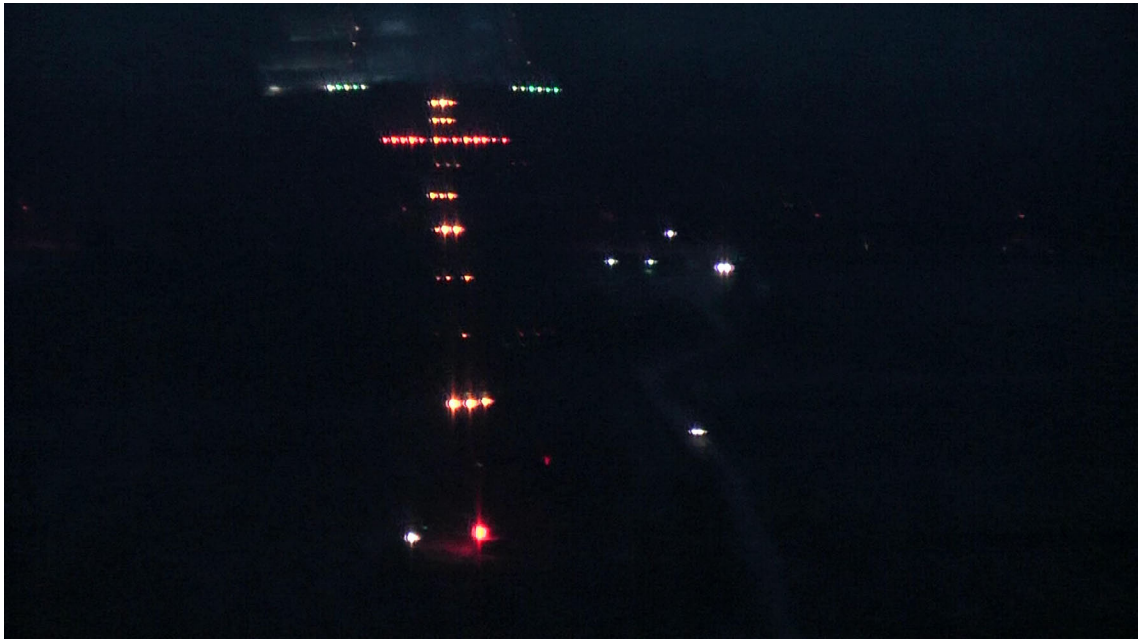
Figure 11

The fly-around check on 15.04.2010 (Figure 12, Figure 13) revealed that in comparison with the shown scheme, there is one more light line at a distance of 100 m from RWY 26 threshold, the actual number of threshold lights (green) is 6 instead of the 8 lights specified in the RTP. The lighting equipment check also revealed that depending on the aircraft position and

It was not possible to determine the condition of the lighting system at the time of the accident. According to the report of the projector driver on 10.04.2010 at 7:00 to 8:00 during the preflight test of the lighting equipment it was in good condition and operative. Right after the accident of the Tu-154M it was impossible to check the operability of the lighting equipment due to dense flight schedule at the airdrome up to 5:00 on 11.04.2010. The investigation team did not receive any complaints from the crews conducting flights in that period. The examination was conducted at 9:00 on 11.04.2010. It revealed that the lights of the second and third group (800 and 700 m from RWY 26 threshold) were missing, there were fragments of lights, the power cable was torn off. The light filters on the firsts group lights (900 m) were broken, only one of the three lights was operative. These light groups are beyond the airdrome, within the city area in easily accessible unsecured areas.

The lighting system was recovered on 14.04.2010 which is confirmed with the data of a fly-around on 15.04.2010.

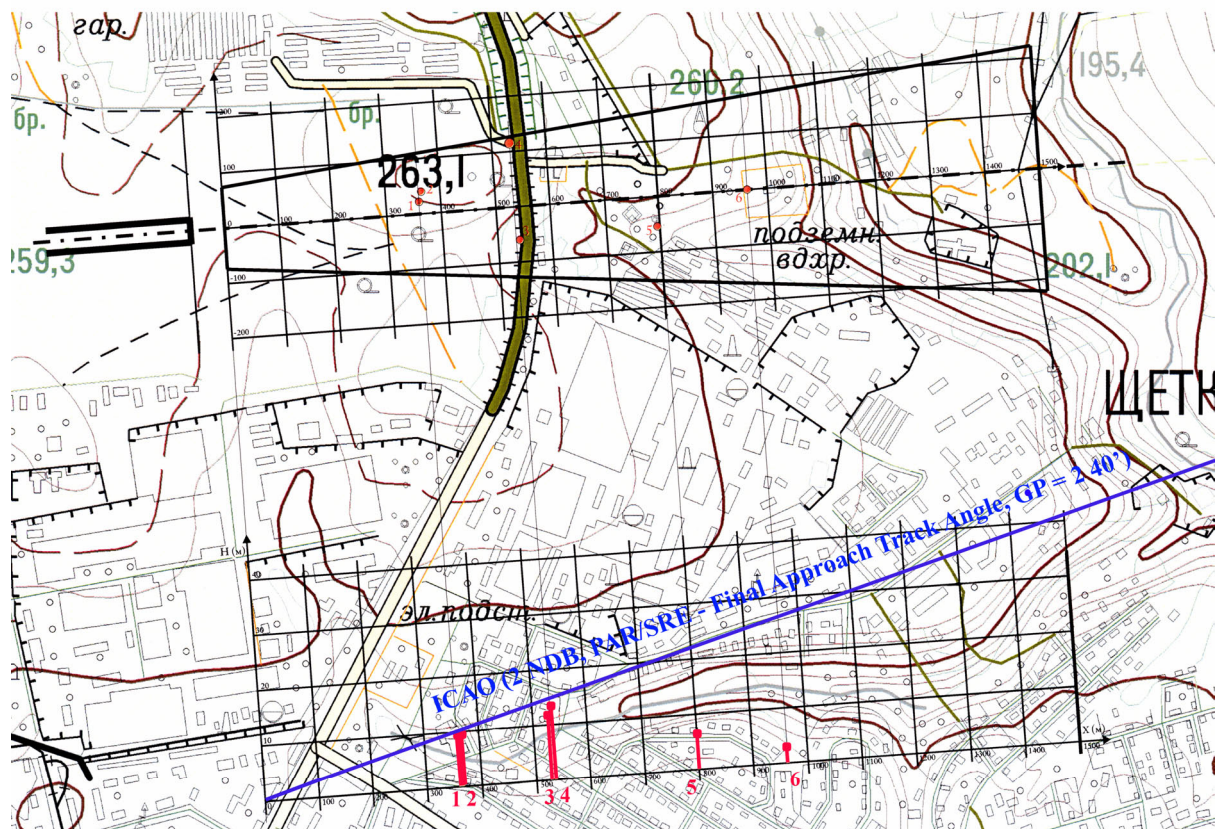
In accordance with ICAO documents (PANS-OPS, Volume II, Part I, Section 4, Chapter 5, Para. 5.4.6 "Protection for the visual segment of the approach procedure") the limit of obstacle height surface for visual approach with glide path angle of $2^{\circ}40'$ requires a slope of $1^{\circ}33'$. As comes from Figure 16 this requirement is complied with. Besides, according to ICAO PANS-OPS obstacles lower than 15 m in the clearway can be neglected when using radar + 2NDB approach. Thus, the glide path of $2^{\circ}40'$ - $3^{\circ}30'$ with course 259° M is suitable for international flights.

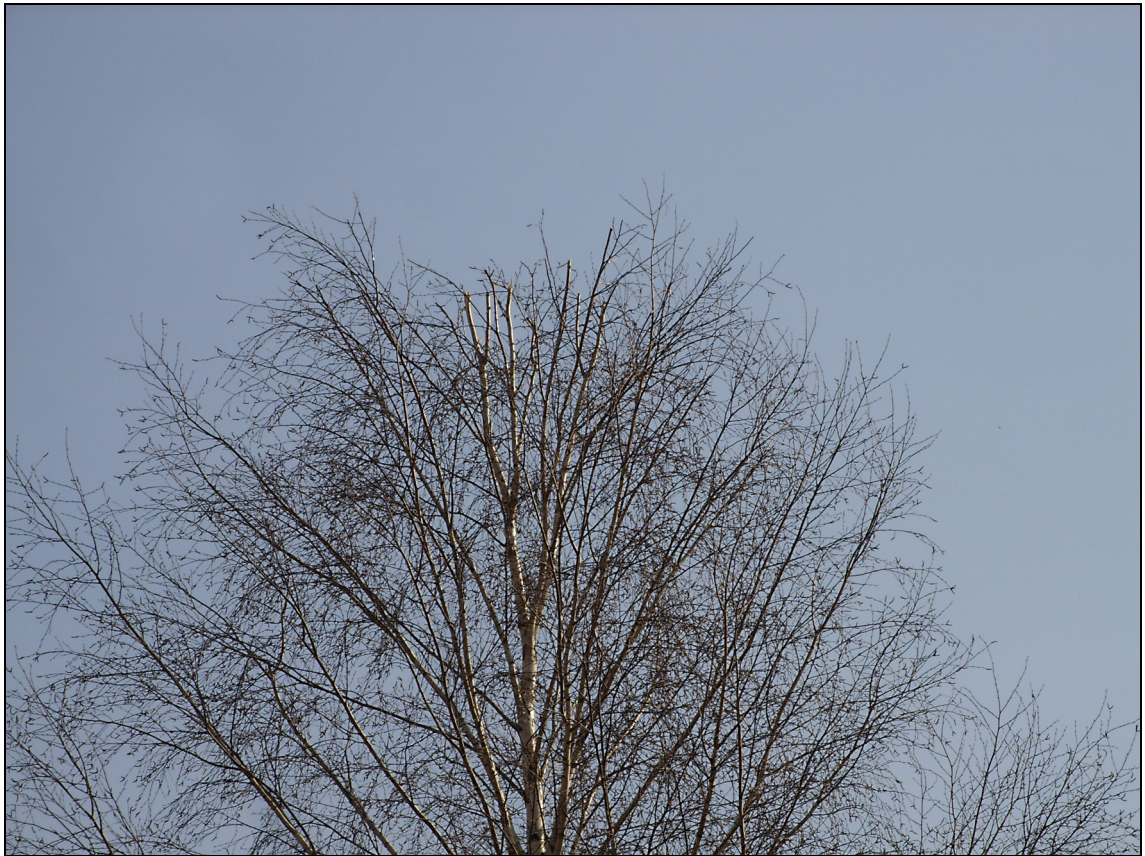
Figure 26

The first impact (aircraft structure not destroyed) was on a tree top at a height of about 11 m near the middle marker at a distance of 1100 m from runway 26 threshold and lateral deviation of 35 m left from the extended runway centerline at a point located N54°49.521' E32°03.65' (Figure 26 and Figure 35). The terrain elevation near the middle marker and place of first impact is 233 m; runway 26 threshold elevation is 258 m. Thus, when passing the middle marker the aircraft was about 14 m lower than runway 26 threshold.

No aircraft elements were found before the place of the first impact.

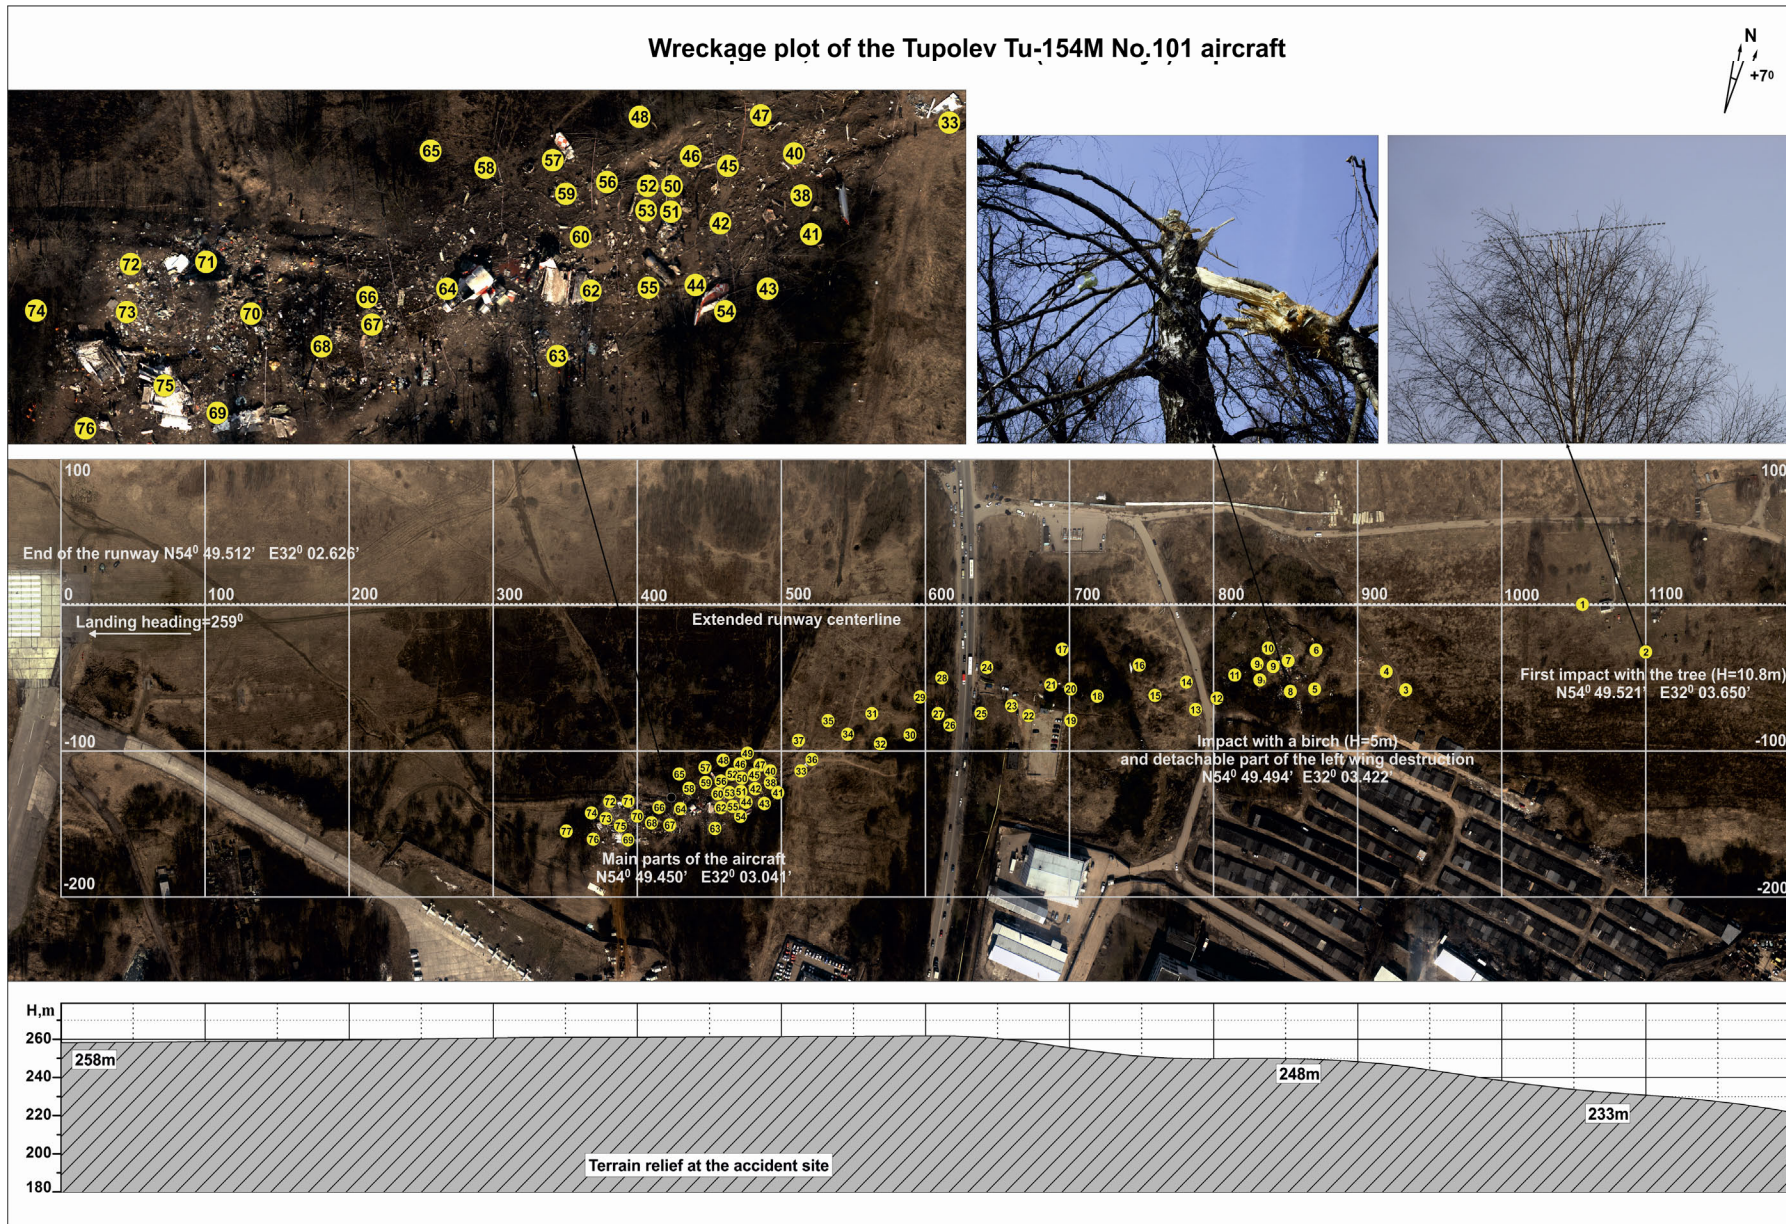
Figure 35

At a distance of 244 m from the first impact with lateral deviation of 61 m left from the extended runway centerline at a height of about 5 meters the aircraft hit a birch with a trunk measuring 30-40 cm in the diameter (Figure 27 and Figure 35).

The following table contains the complete list of the aircraft fragments on the wreckage plot (Figure 35).

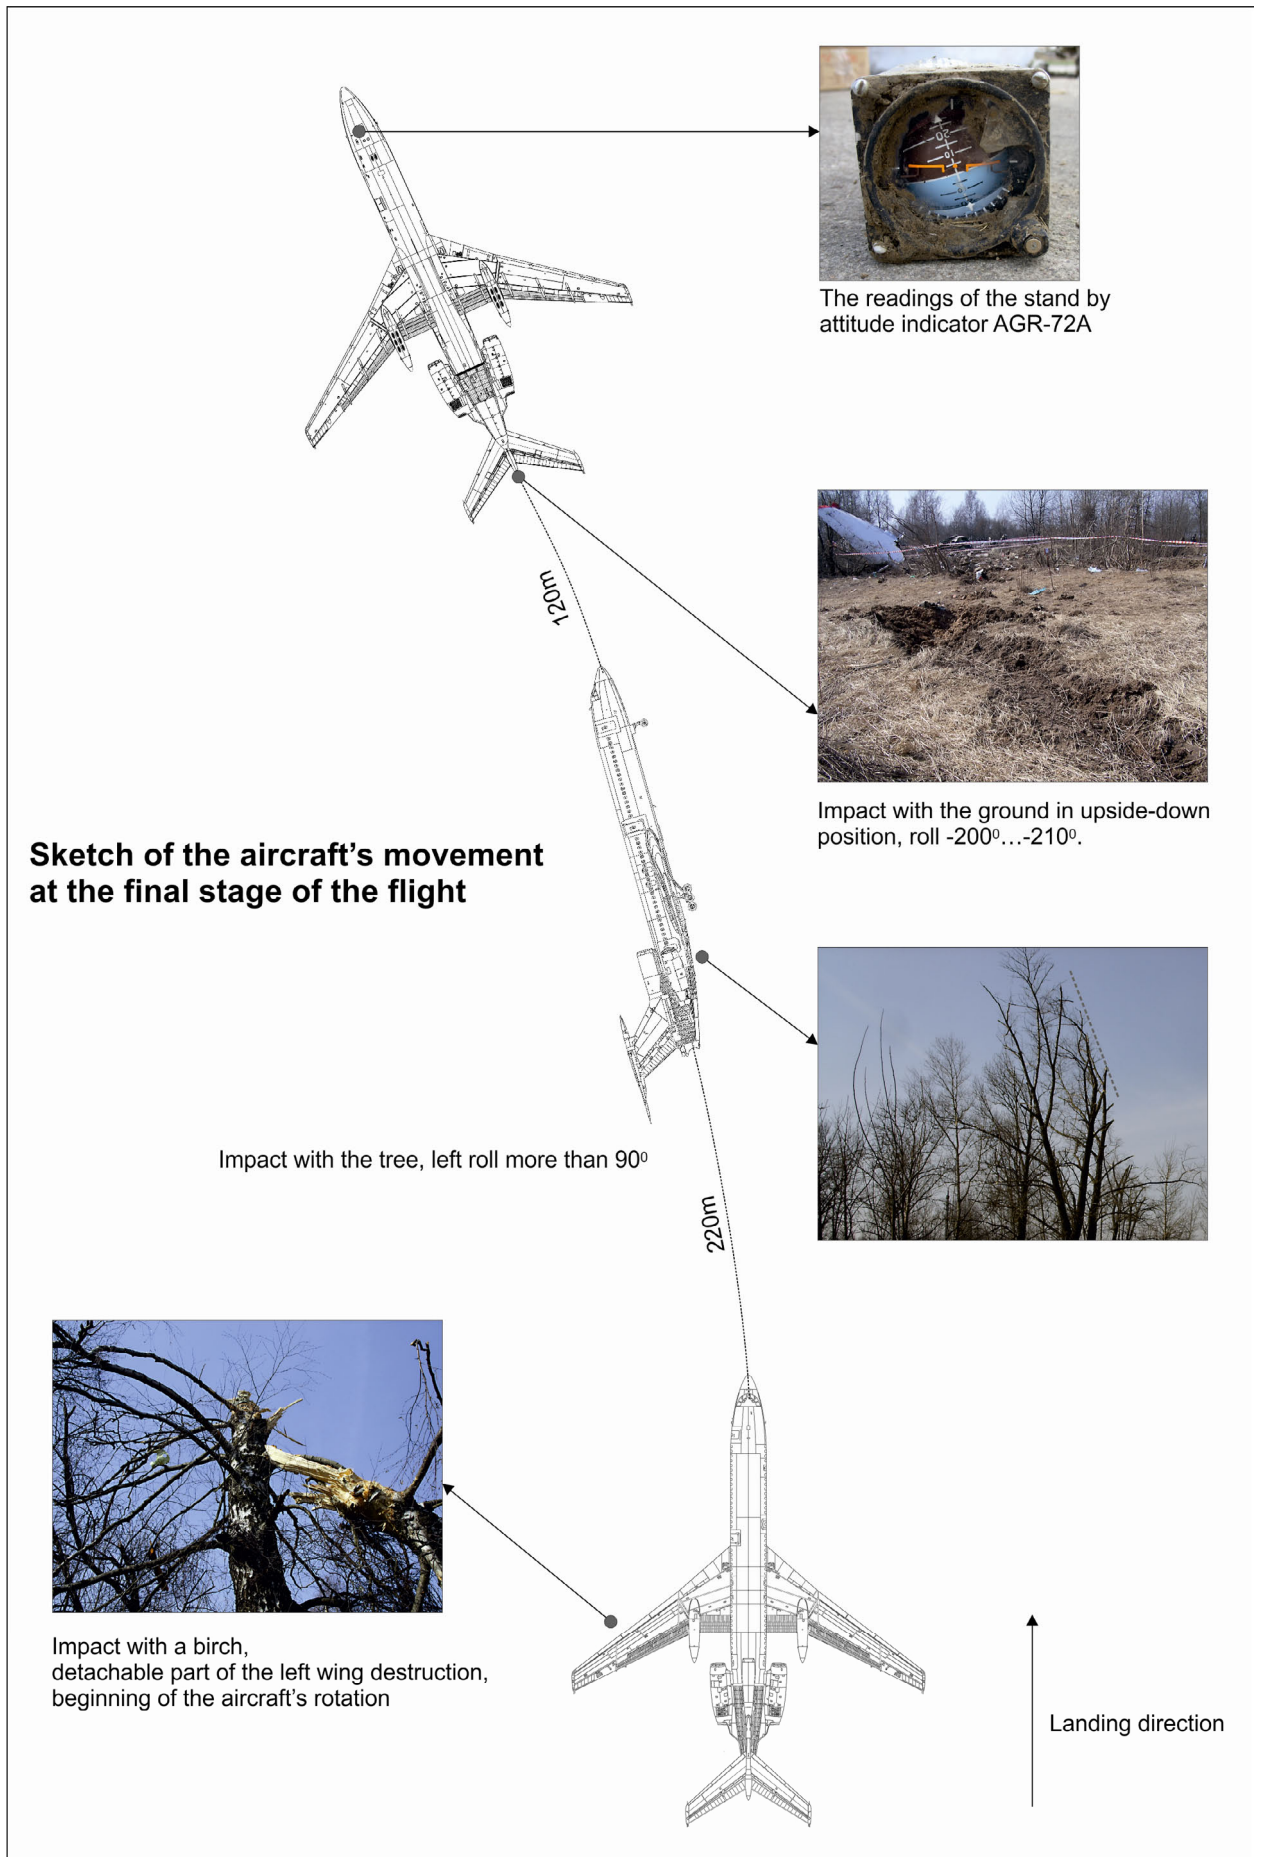
Figure 36

While rotating and moving farther the aircraft got further structural damages caused by the impact on the trees. The nature of the tree rip-off at a distance of 465 m from the first impact assumes that by that moment the left bank was over 90° (Figure 29 and Figure 36); at a distance of 530-550 m from the first impact the investigation team found fragments of the wing primary structures partition, fragments of the left stabilizer panel with elevator and rudder and elevator rods.

The traces of the impact on the ground and their distribution allow to conclude that the impact occurred when the aircraft was rolling left and on impact the aircraft was inverted with a left bank of about 200° - 210° (Figure 36).

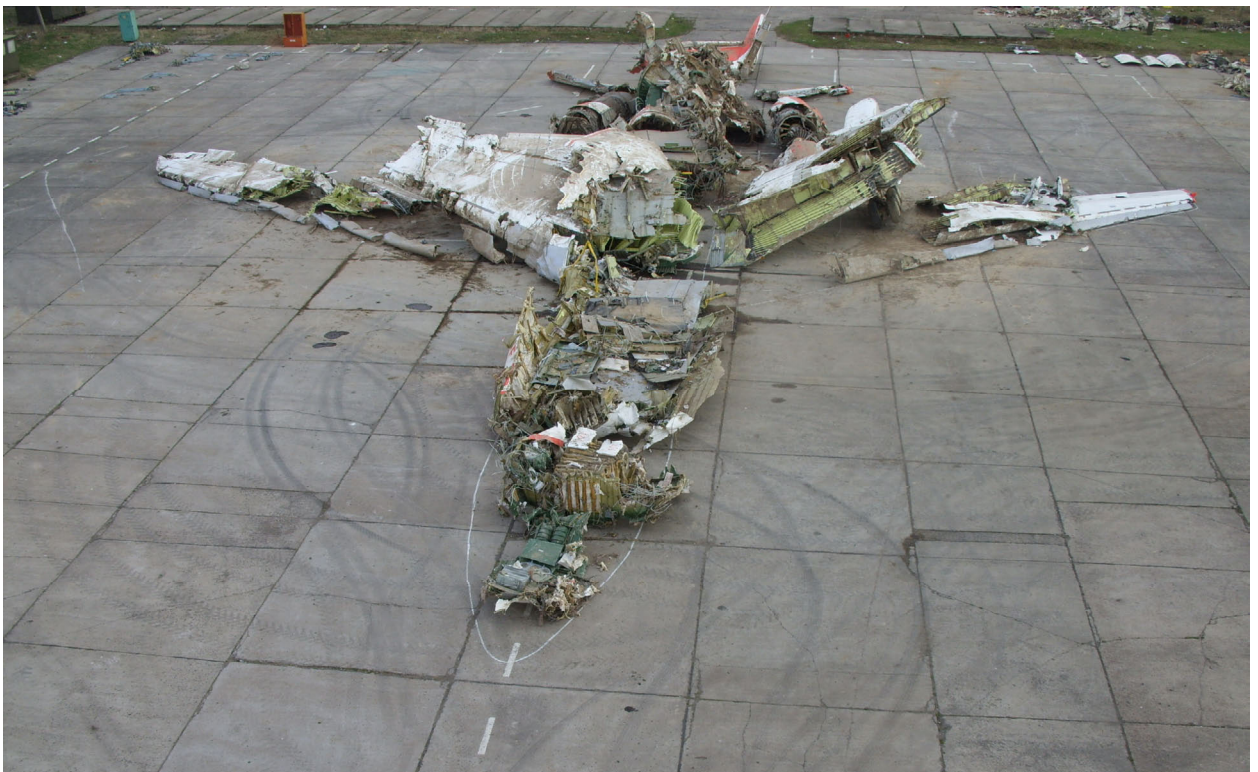
Figure 37

From 13.04.2010 to 16.04.2010 the aircraft fragments were evacuated to the secured site and the aircraft airframe (Figure 37), avionics and flight control systems were laid out.

As the aircraft impacted the ground inverted the radome, cockpit light and upper part of the fuselage from frame 4 to frame 67A were totally destroyed into small fragments difficult to identify.

On the basis of the layout analysis it can be definitely concluded that the destruction of the aircraft structures and systems was caused by the unexpected impact forces, no traces of the in-flight fire were detected.

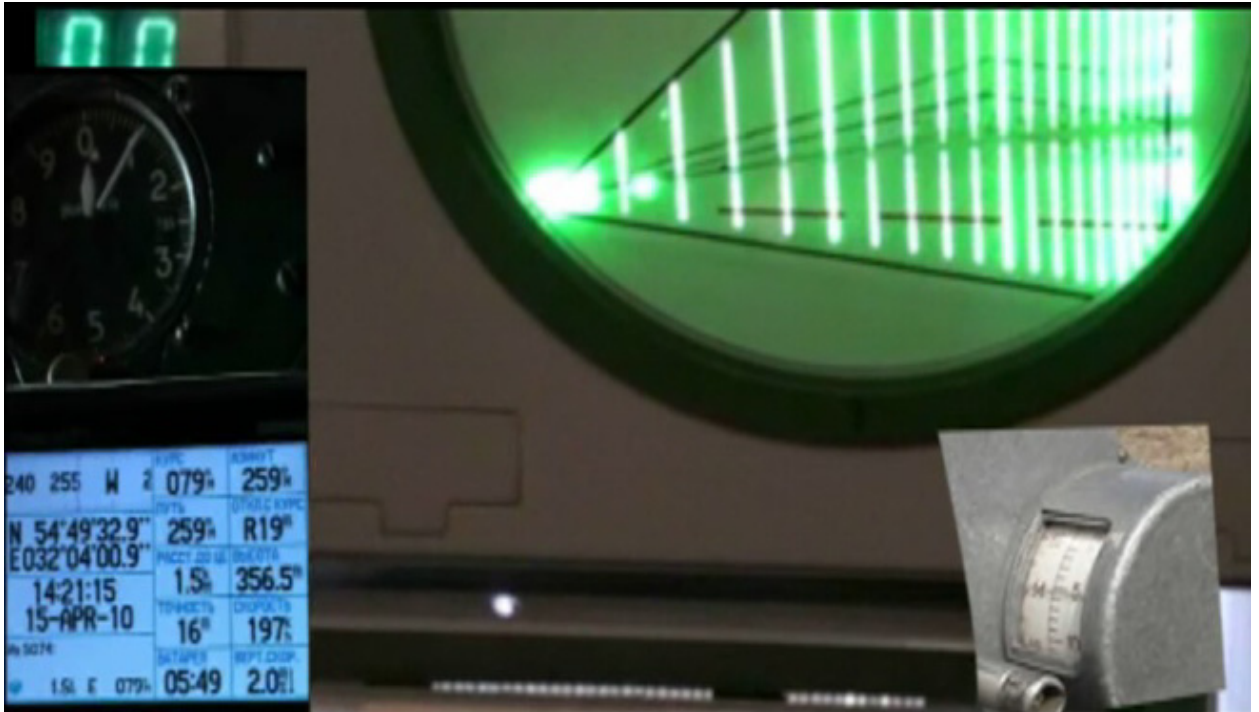
Figure 38

The minimum required landing radar range of 1.5 km in the passive mode (used in the accident flight) (Figure 38) and of 1 km in the active and moving aim selection modes is provided. In the passive mode the blip disappears about 1.2 km from RWY 26 threshold (Figure 39).

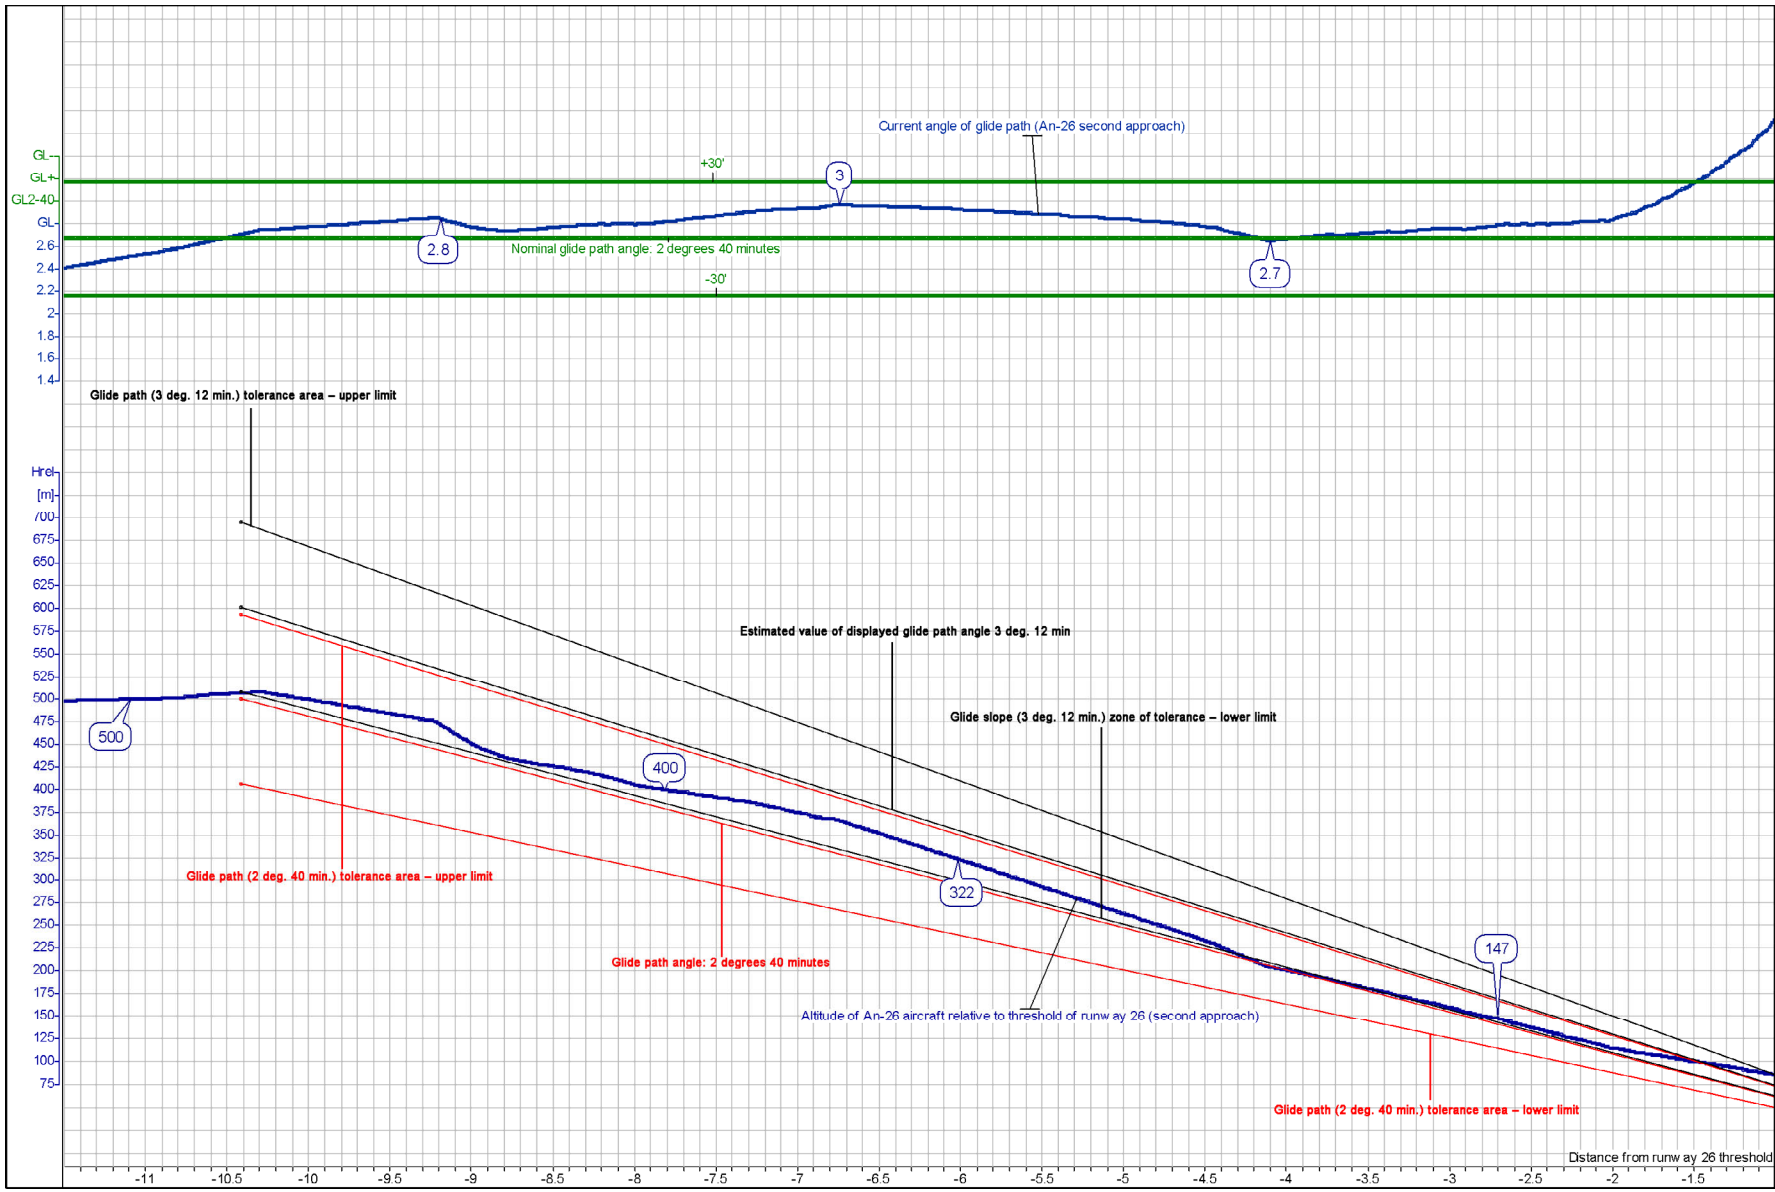
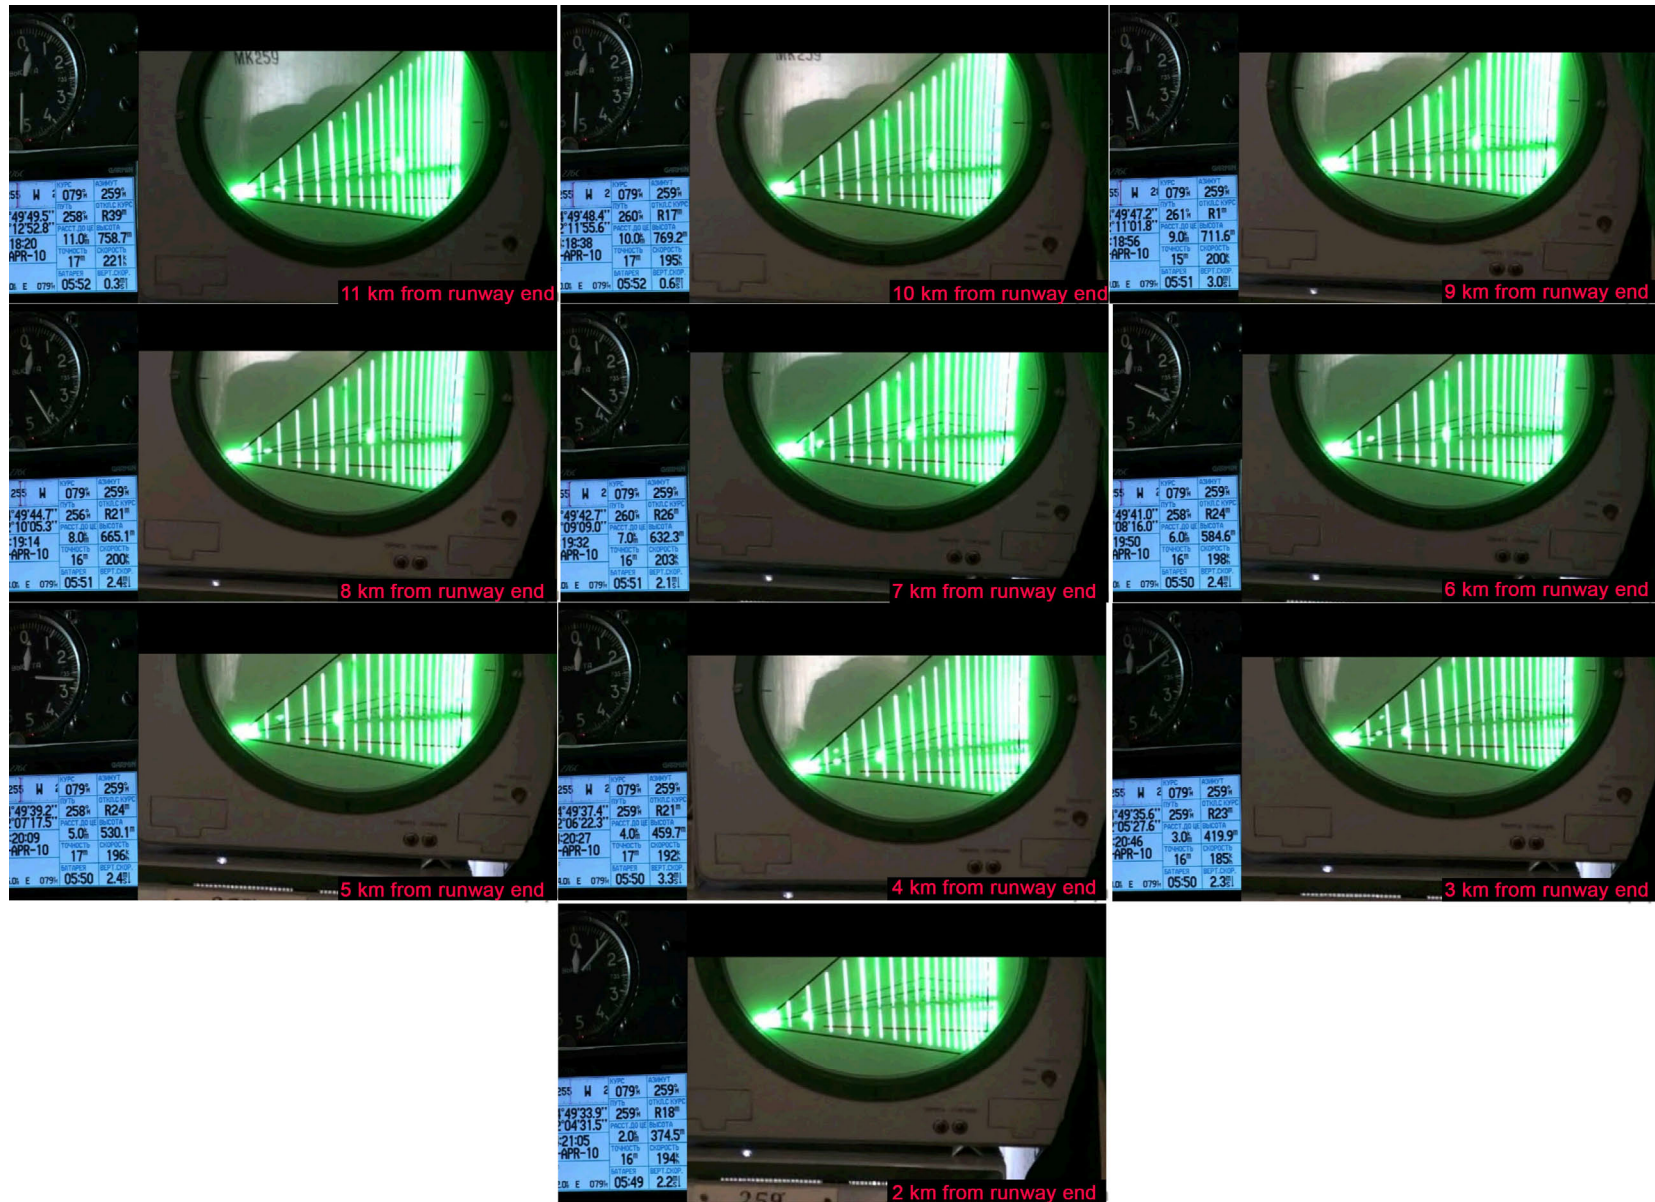
The analysis findings are shown on Figure 40 and Figure 41. The first chart shows the changes in altitude in the test flight as a function of the distance from RWY 26 threshold. The chart also shows the nominal glide path, the area of tolerable deviations and the so-called momentary glide path angles. These angles are calculated as arctangent of the quotient from dividing the current altitude by distance to the touchdown point when following the nominal glide path (the touchdown point is 320 m after the runway threshold).

- 1 The landing radar screen mounted for the experiment (and during the accident flight) had lines approximately designating the following angles (shown in black on the chart):
 - Lower line - $2^{\circ}42.3'$;
 - Central line - $3^{\circ}12.3'$;
 - Upper line - $3^{\circ}42.3'$;
- 2 The landing radar underrates the indications of the aircraft distance from the runway threshold by about $90 \div 150$ m (depending on the distance of the aircraft from the runway threshold).

Thus, in the accident flight the landing zone controller saw the aircraft blip on the radar as being referenced to glide path of $\sim 3^{\circ}10'$. The inaccuracy was about 0.5° , which is equal to the tolerance area range.

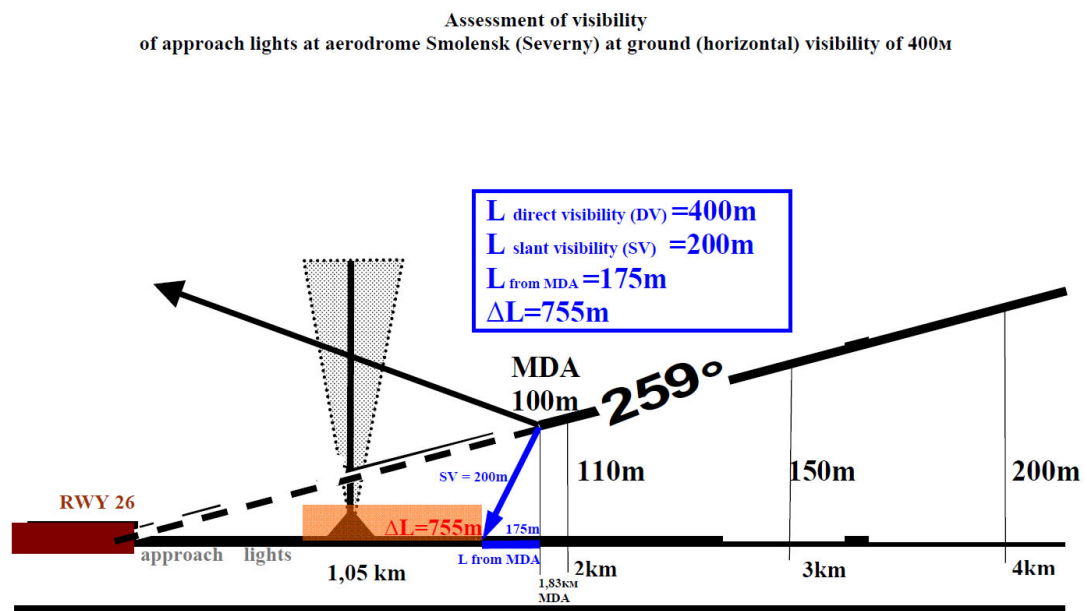
To assess the visibility of the lighting system elements in actual weather conditions a relative chart was prepared (Figure 42). For the assessment purposes the direct visibility was taken as 400 m. The Ratsimor method was used to converse the direct visibility to slant one: $L(\text{slant visibility}) = k * L(\text{direct visibility})$. If the cloud base is lower than 100 m $k = 0.2 - 0.45$. To make the calculations the conversion coefficient of 0.5 was taken with a margin. Thus the calculated slant visibility was 200 m. When on the glide path the aircraft should have passed the decision altitude (100 m) at a distance of 1800-1850 m from RWY 26 threshold. The following chart shows that the crew could not have established visual contact even with the first line of approach lights (900 m from the runway).

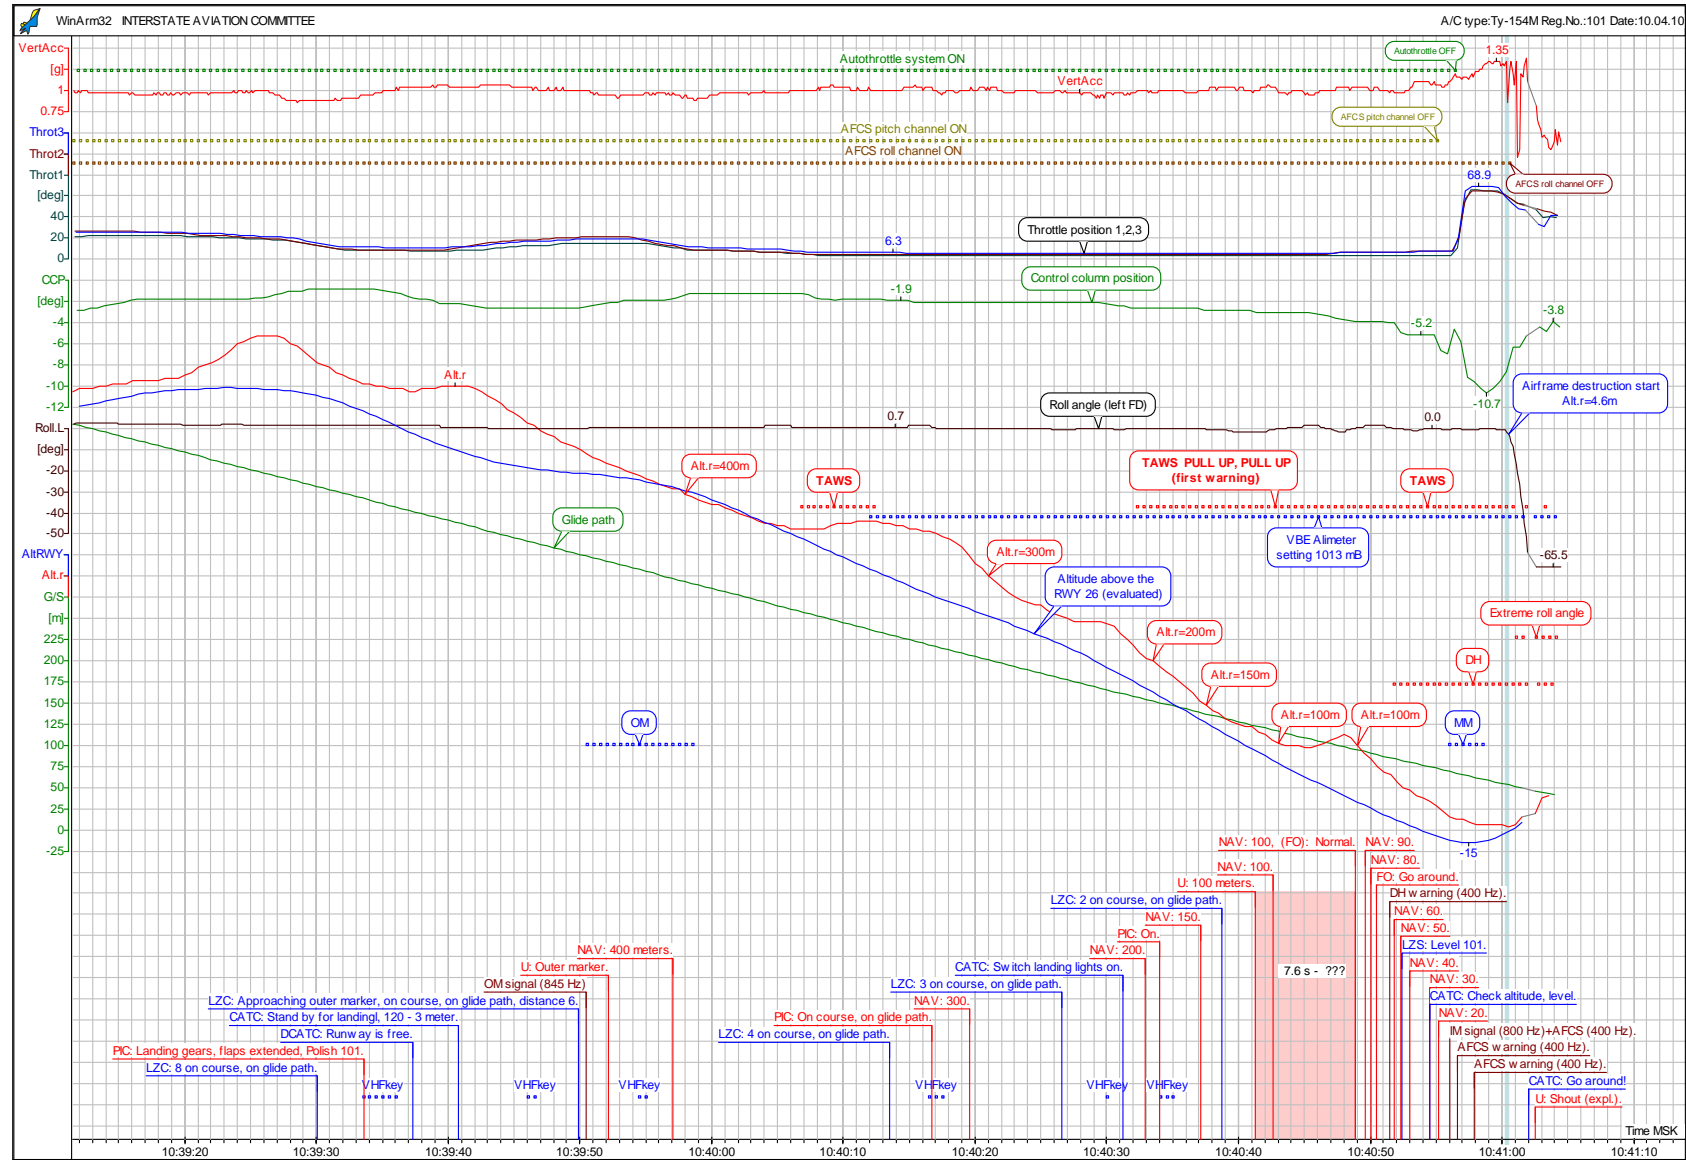
At 10:40:20 the navigator reported the height: “300”. The comparison of this and further navigator’s reports on the flight height (250 m, 200 m, 150 m, 100 m) with the actual pressure altitude and radio height especially in the time interval from 10:40:41 – 10:40:49 indicated in color on Figure 45 reveals that at least from that moment the altitude was monitored by the radio altimeter⁵⁰. It should be noted that the navigator had not conducted flights on Tu-154M flying as a co-pilot of Yak-40 for the last 2.5 months. The interview of the Yak-40 PIC who was flying to Smolensk "Severny" Airdrome on April 7 and 10 showed that for the crews of Yak-40 in the regiment “there is a procedure of monitoring altitude by the radio altimeter from the height of 250 m”. The actual terrain along the flight path is shown on Figure 46. It is clear from the picture that after the outer marker the terrain level was much lower than RWY 26 threshold (up to 80 m).

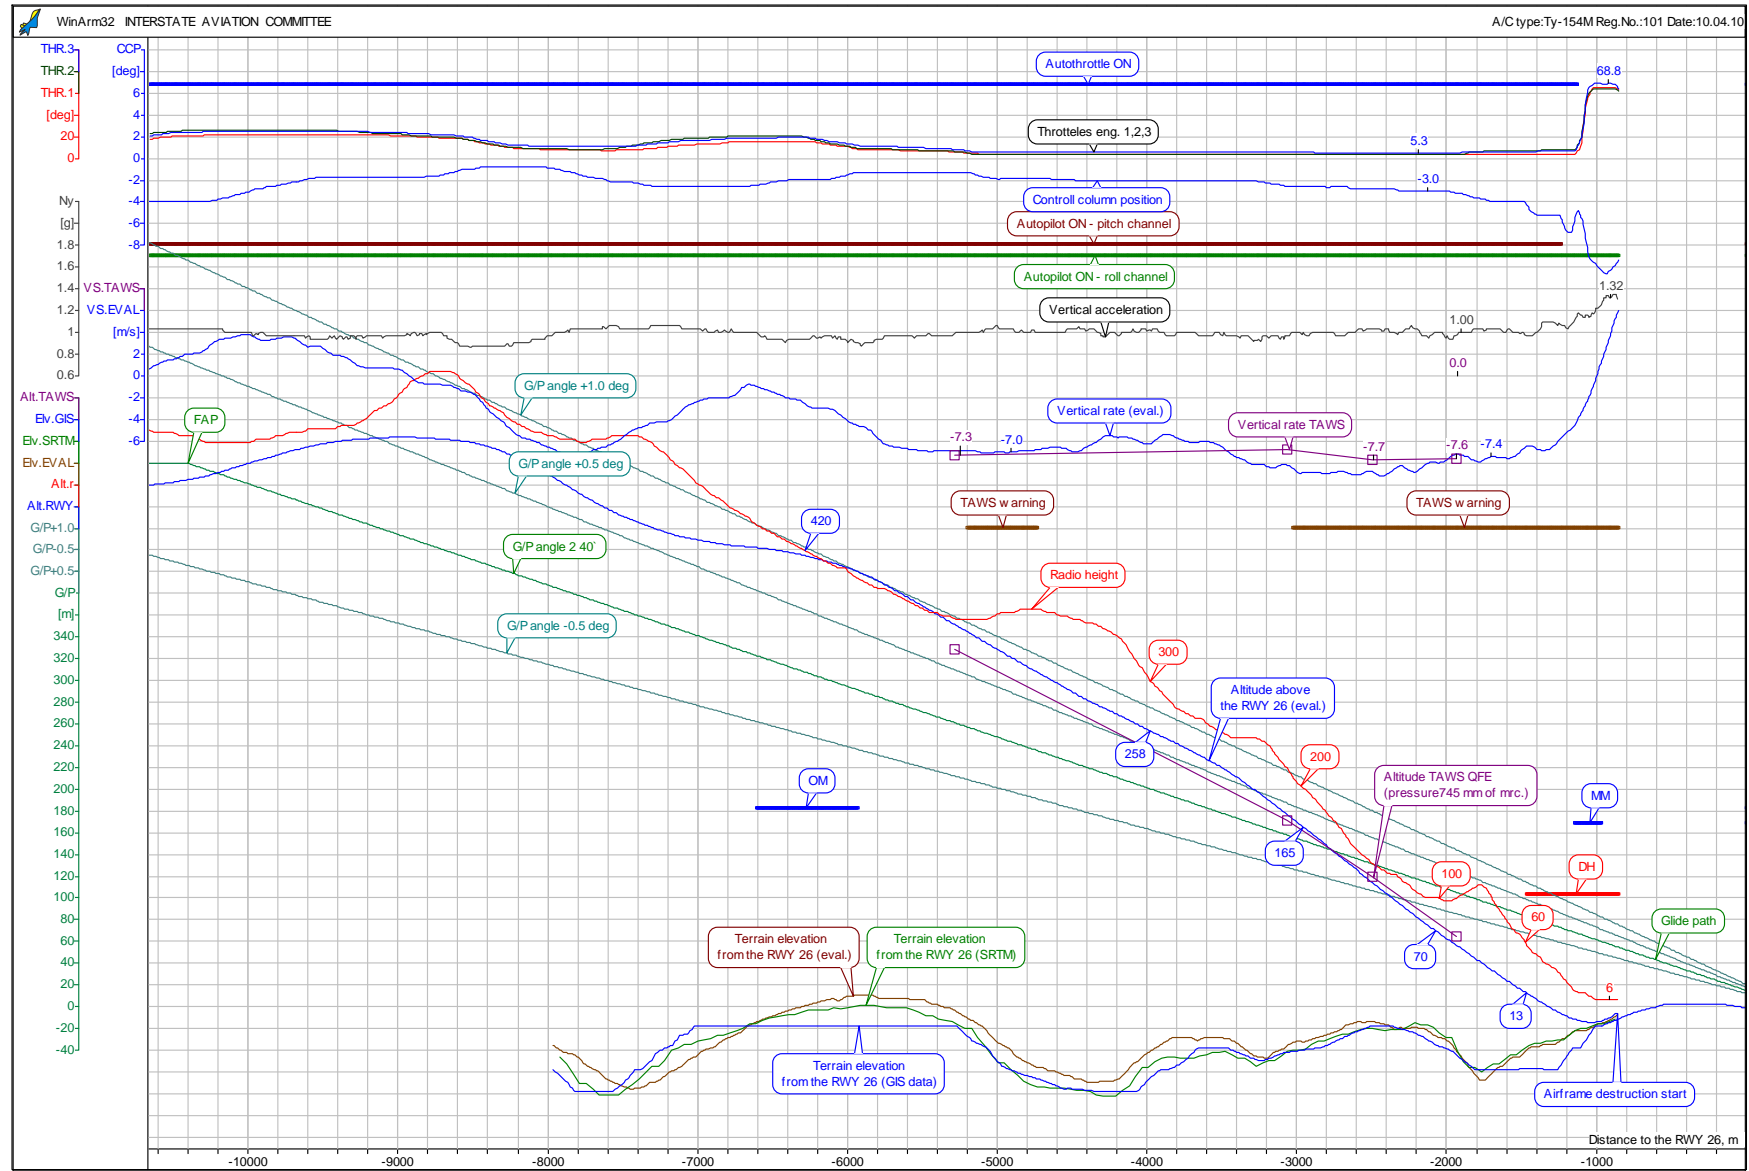
Figure 46

The actual descent path of the aircraft is shown in Figure 45 and Figure 46.

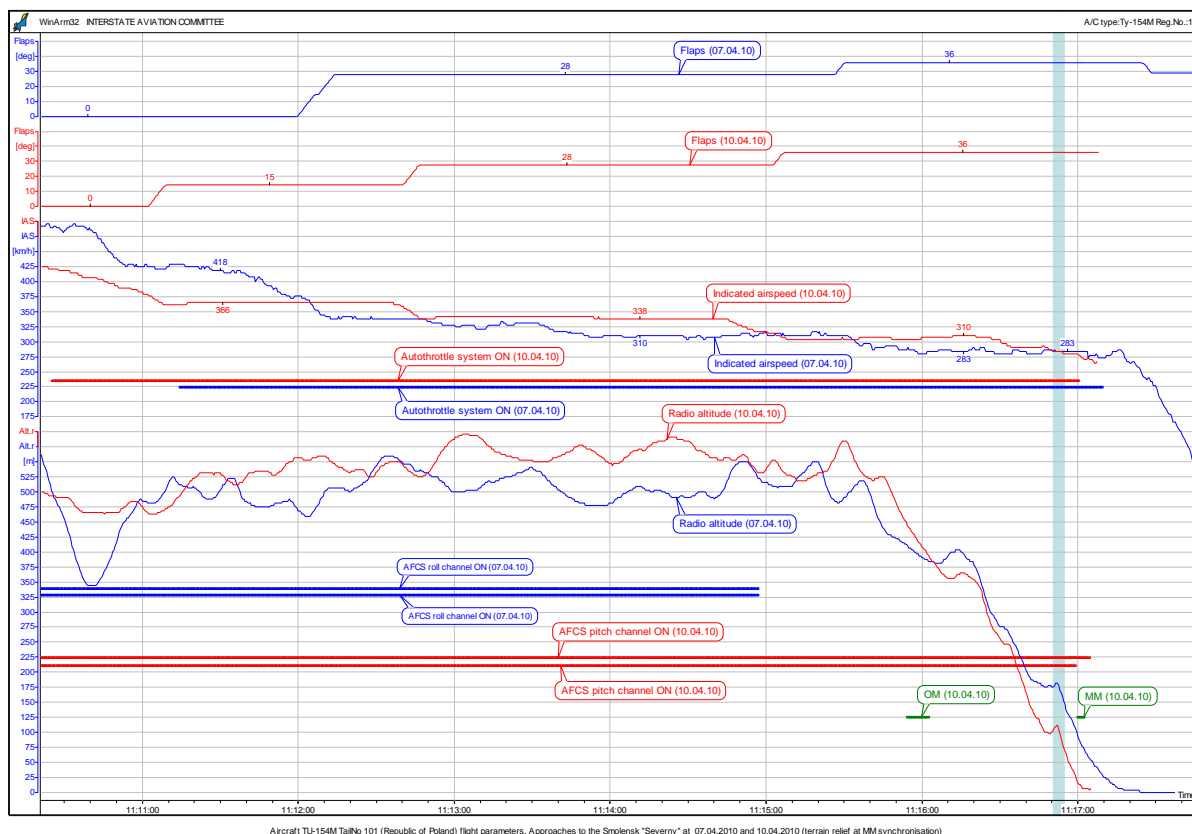
Figure 47

Note: *The analysis of the flight made to Smolensk "Severny" Airdrome on this aircraft on April 7, 2010 reveals that the crew switched to manual control column steering before starting the glide path descent (Figure 47).*
