This document is an English translation of the Final Report on the accident on 10 April 2010, on Smolensk "Severny" airdrome, to the Tupolev Tu-154M tail number 101 of the Republic of Poland.

**INTERSTATE AVIATION COMMITTEE
AIR ACCIDENT INVESTIGATION COMMISSION**

FINAL REPORT

| Type of aircraft | Airplane, Tu-154M |

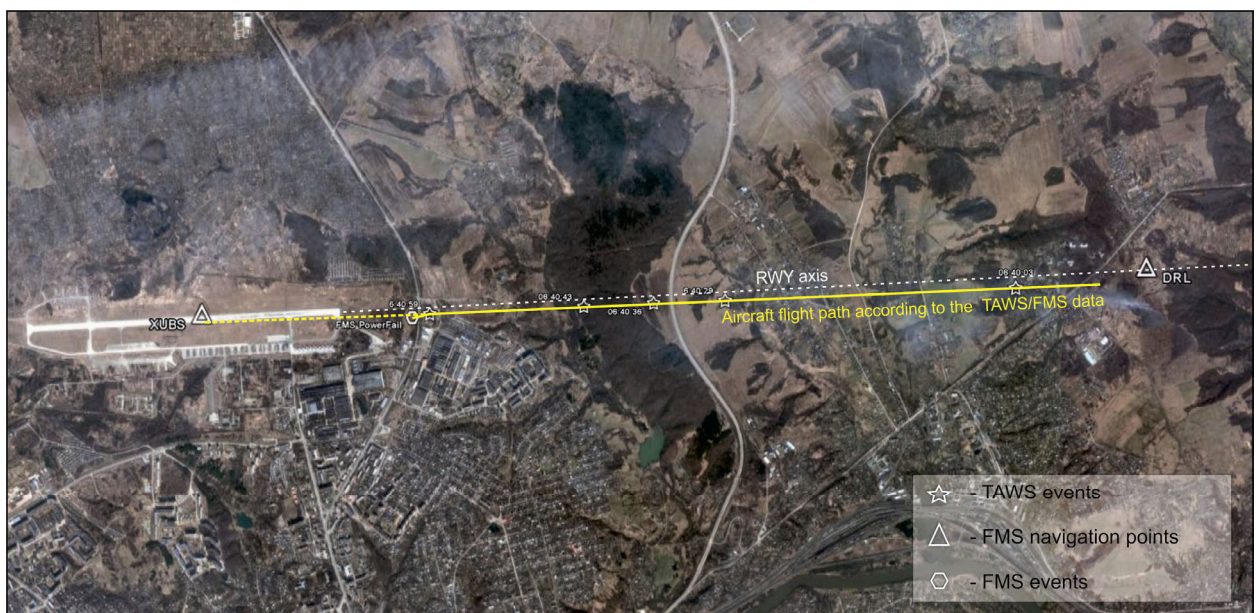
Figure 48

From the outer marker to XUBS (the last waypoint in the active flight plan), the flight path calculations (Figure 48) suggested two possible methods as to how the flight crew was controlling the airplane - either by the FMS, or by the use of the TURN (HEADING) knob. The flight path calculations revealed that, after passing the outer marker, the airplane was to the left of the extended runway centerline (within the course tolerance area) heading directly to the XUBS waypoint. It is possible the FMS could have provided the course adjustment for the airplane to track directly to XUBS and, therefore, converge on the line between the waypoints. In addition, the flight crew could have used the autopilot TURN (HEADING) knob to adjust the airplane's track.

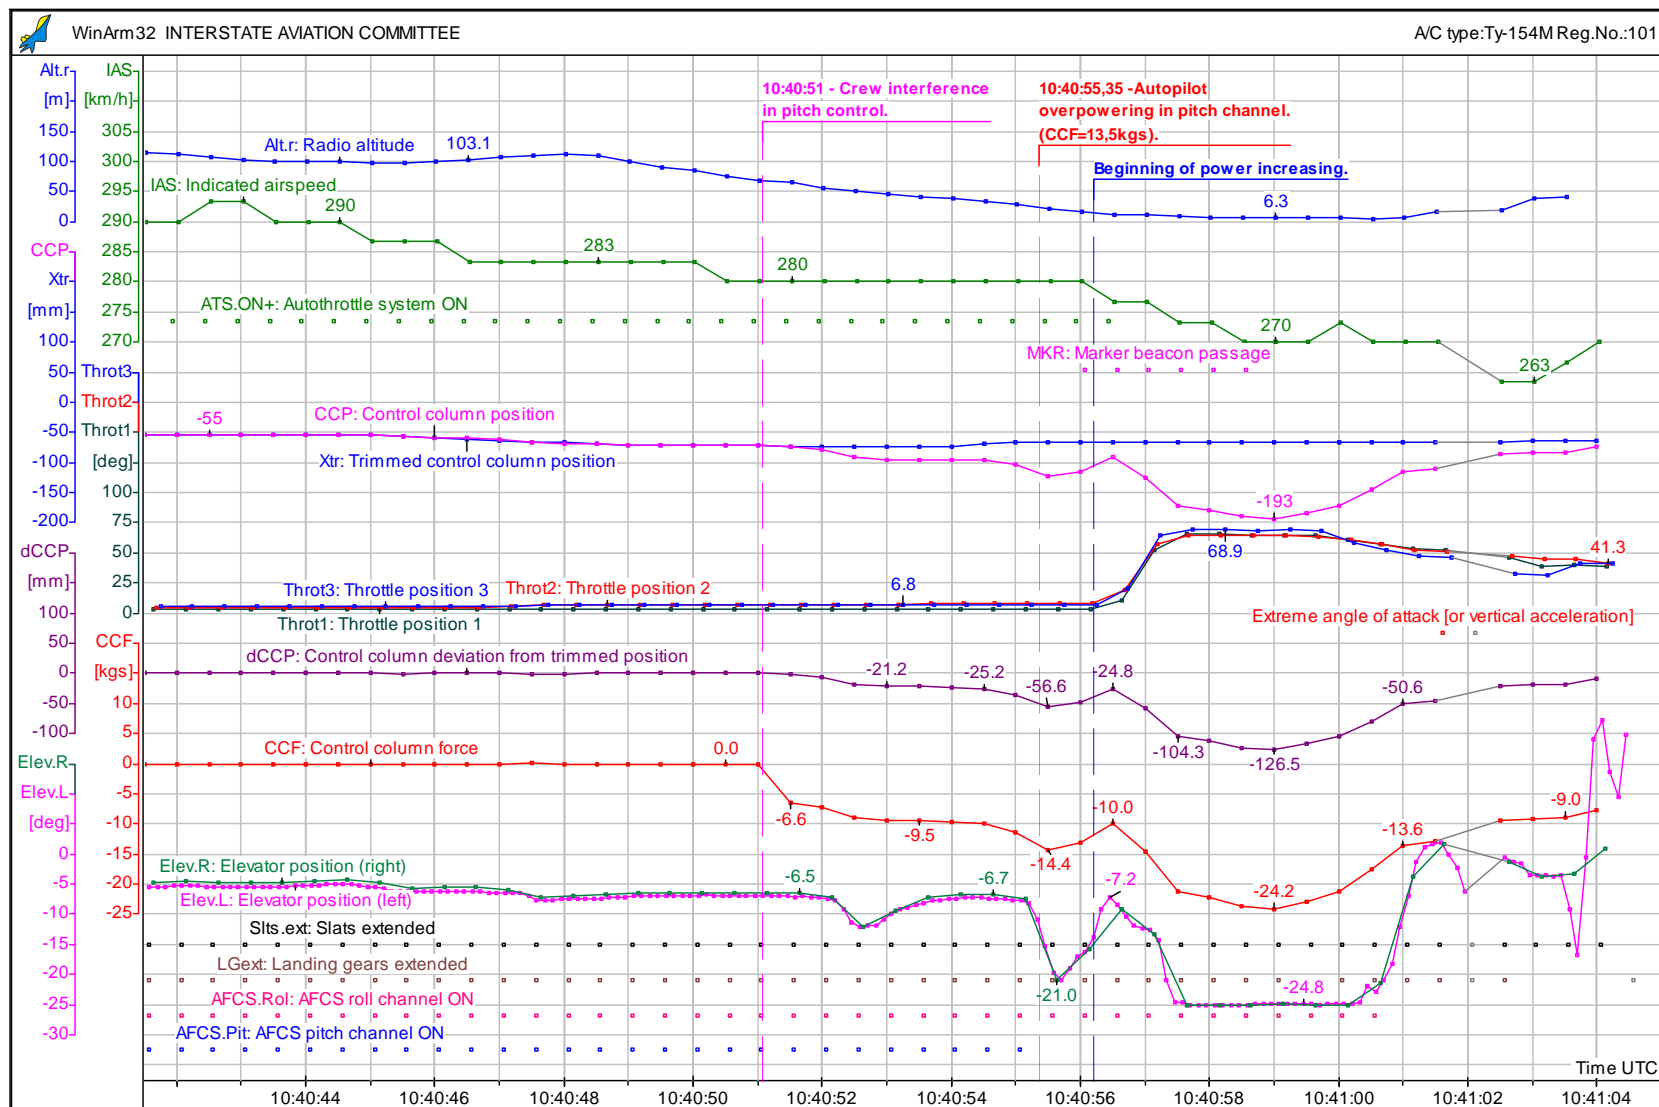
Figure 49

At 10:40:55 at a height of about 30 m the CATC instructed: "Check altitude, level" and simultaneously the control column was abruptly pulled up (moving the elevator to 20° pitch up, load forces up to 15 kg) which led to autopilot being overpowered in the pitch channel. In a second throttles of all engines were set to takeoff mode (with a rate of one second) which led to the disengagement of the autothrottle. Usually when the missed approach is made in control column steering mode the autopilot is disengaged by pressing the quick switch-off button on the pilot's control wheel.

Calculated forces on the control column.
